2015 NIST Investigation of PMU Response to Leap Second

NISTIR 8077

Investigation of PMU Response to Leap Second: 2015

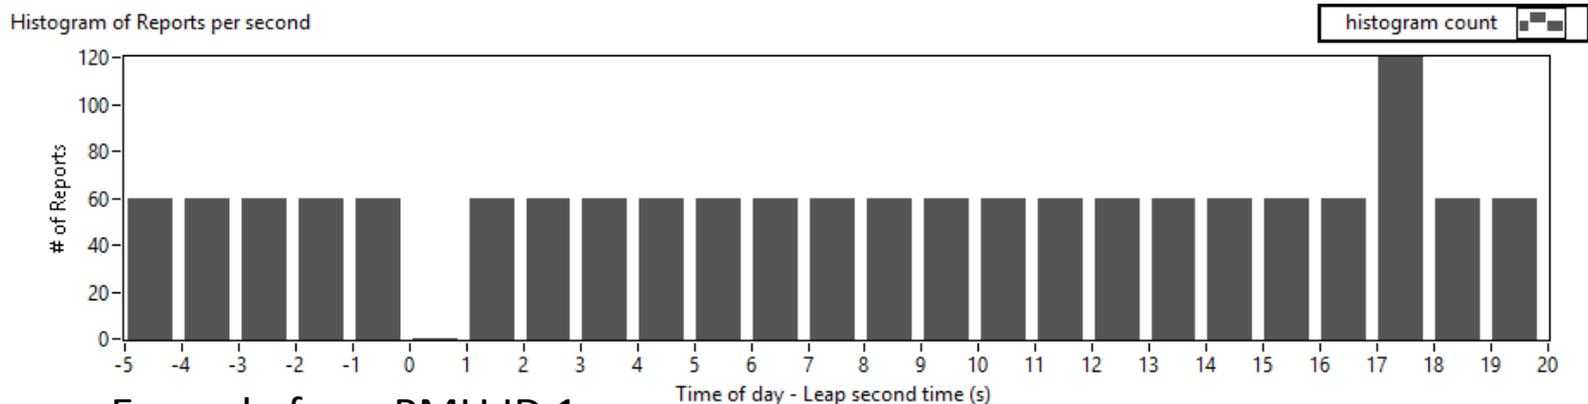
What happens when the time is not synchronized?

- “Missing” reports (the time never happened)
- “Duplicated” reports (reports that should have had a different time stamp)

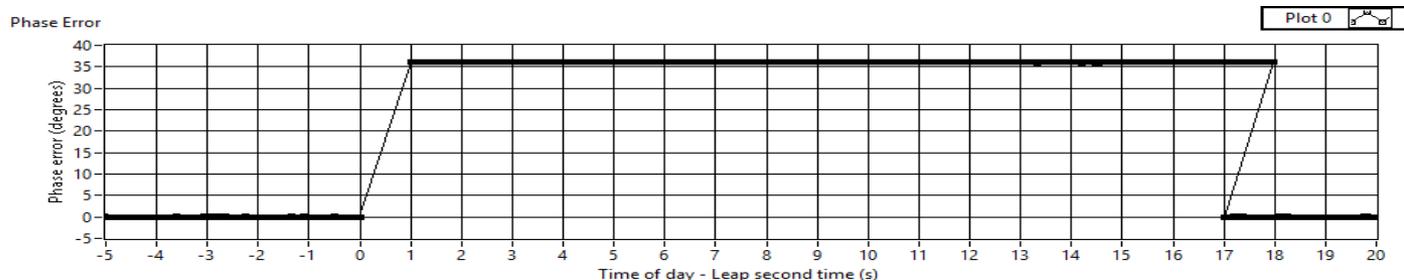
Again, an example from PMI ID 1

- for reports with incorrect time stamps, the phase angle “error” depends on the system frequency
 - At nominal frequency the phase angle is not changing.
 - So we ran the test at a constant 59.9Hz system frequency so you can see the phase angle “error”

- For 17 seconds, it appears like the phase has a 36 degree error (at 59.9Hz)
- Note that there are no reports for the second immediately following the leap second
- And there are two sets of reports for the second between 17 and 18 seconds after.
