# **Encounter with Leap Second –**

## ***Experience in Indian WAMS***

**Power System Operation Corporation Ltd.**  
**(POSOCO)**

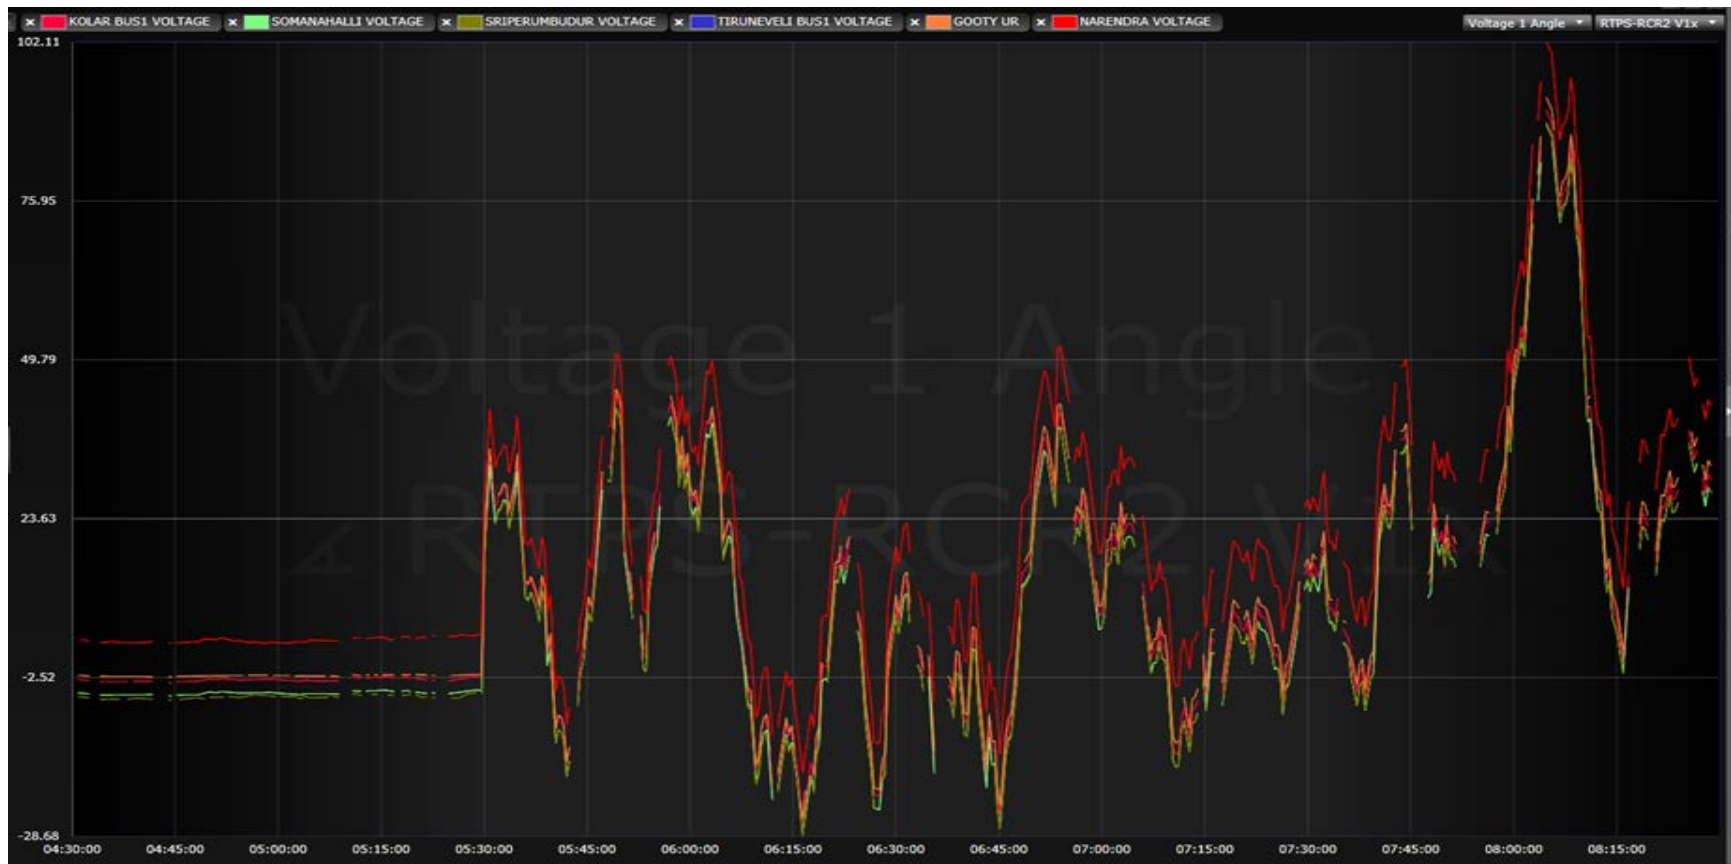
- Random changes observed in trend of **angular** difference in some PMUs after 23:29 at National Control Center.

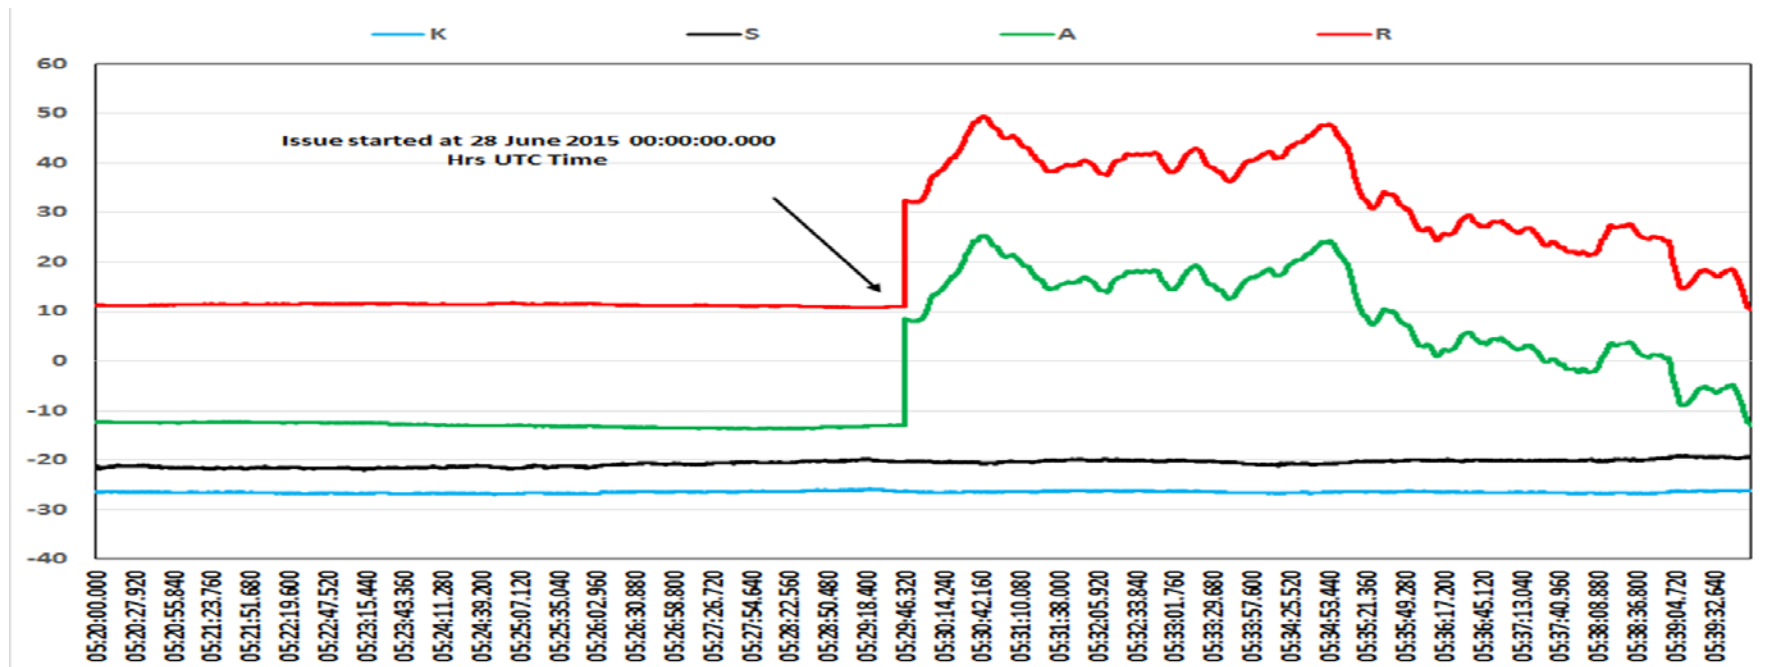
- Operators panicked – but no causing grid events or incidents reported.
- Also no oscillations observed in any part of the grid.
- Erratic behavior was observed in data of some PMUs.

- PMUs got divided into two groups.
- Relative angle between one group of PMU with respect to PMUs from the other group varied considerably.
- Analysis revealed that there is **1 second drift in time of one group of** PMUs w.r.t. others.
- It was concluded that some of the PMUs had added the leap second in advance.
- **It was strange phenomena to us.**
- On restarting GPS, PMU data returned to normal.
- Patch released earlier by the vendor but not applied to these PMUs.

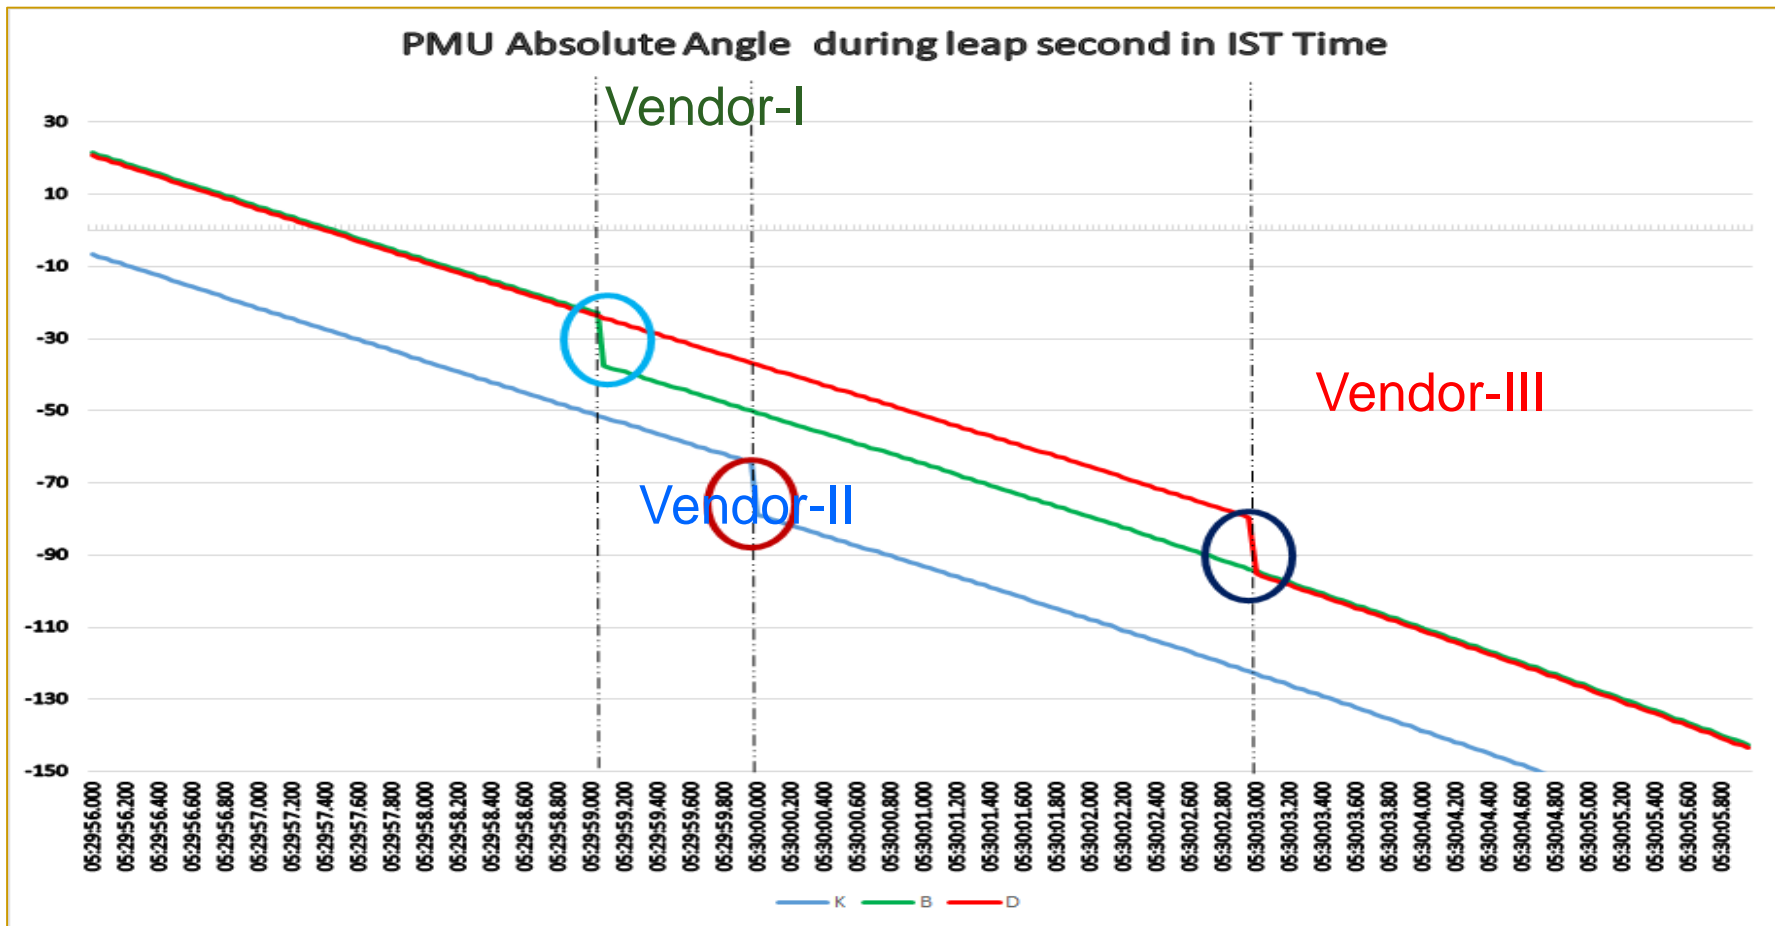
- On 30 June 2015 23:59 UTC (scheduled leap second addition), PMUs responded differently and there were at least four types of response to leap second insertion:
  1. PMUs which added leap second at 05:29:59.000 IST
  2. PMUS which added leap second 05:30:00.000 IST
  3. PMUS which added leap second 05:30:03.000 IST
  4. PMU which did not do any addition of leap second.

Different make GPS/PMU adding leap second not exactly at 23:59 hrs .
