## EI Oscillation Event

January 11, 2019 Event

Tim Fritch, SMS Vice-Chair  
NASPI Meeting, April 17, 2019

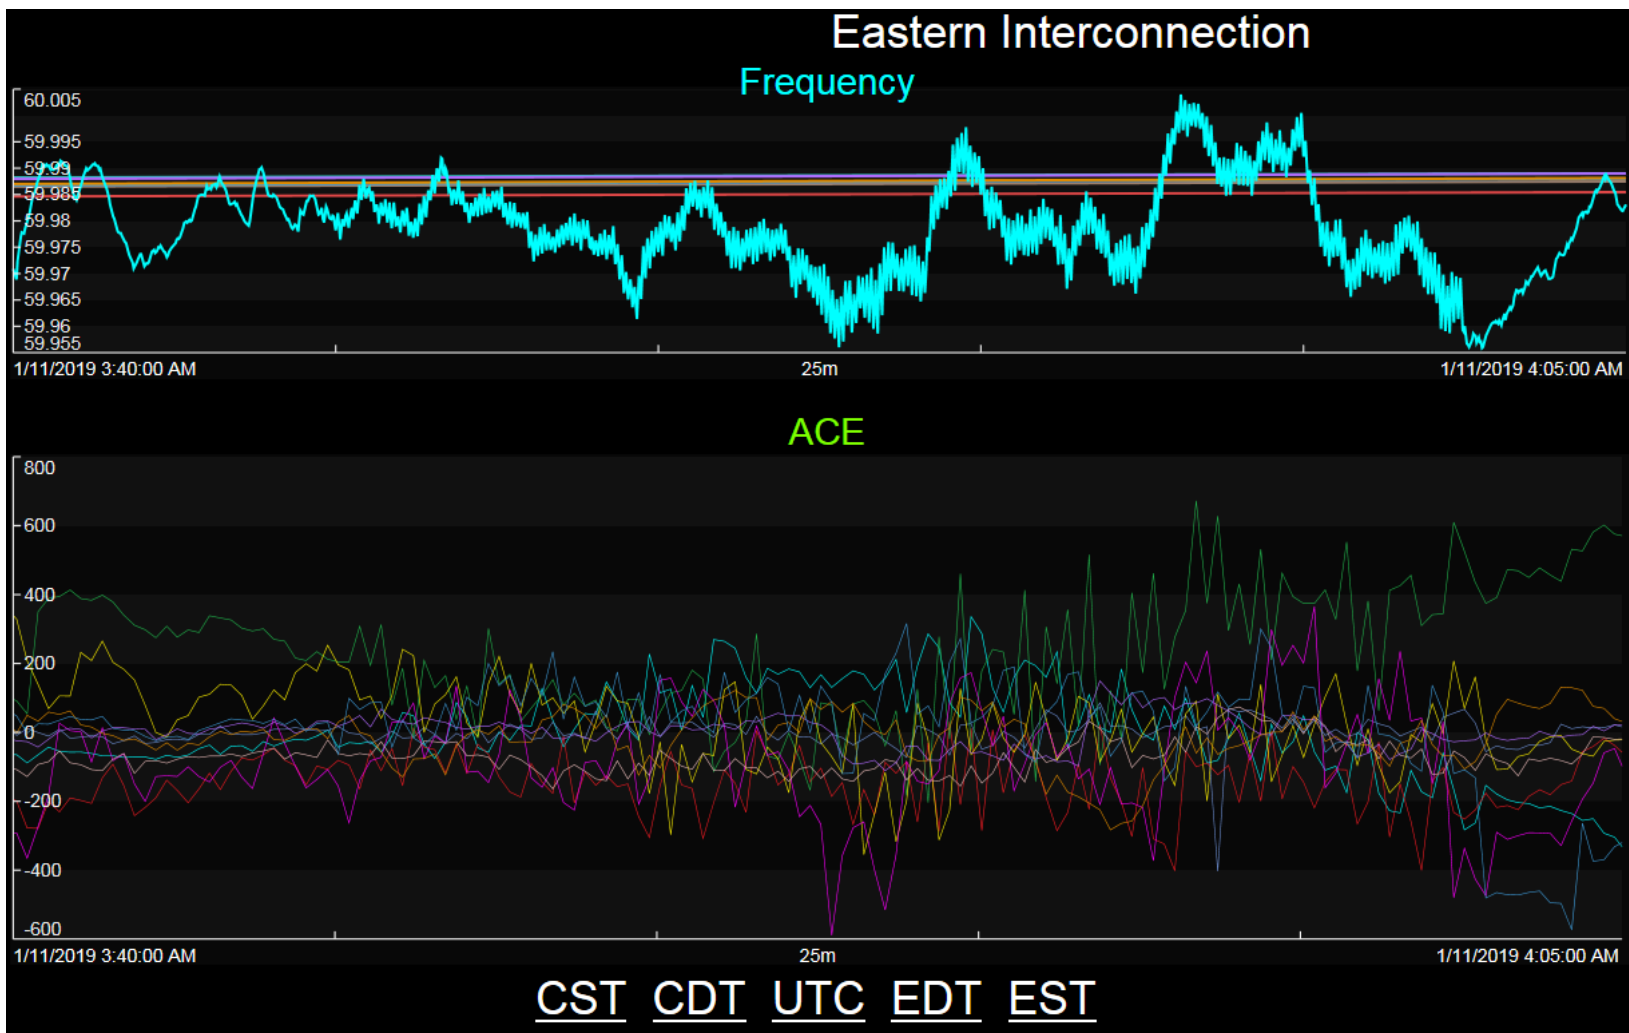
- Oscillation observed across entire Eastern Interconnection from 08:44:41 UTC (03:44:41 EDT) to 09:02:23 UTC (04:02:23 EDT)
  - Oscillation frequency of 0.25 Hz
    - Aligns with inter-area mode frequency across EI
  - Power swings around Florida of 200 MW, around ISO-NE of 50 MW
- RCs identified oscillation on PMU data, notified RC Hotline
- UTK provided videos of oscillation event
- GOs noticed oscillation on power plants across EI
- Source tentatively identified in Florida
- NERC issued PMU data request, working with possible source
- NERC will perform oscillation analysis on wide-area data set
- NERC working with industry to study event, develop mitigating actions

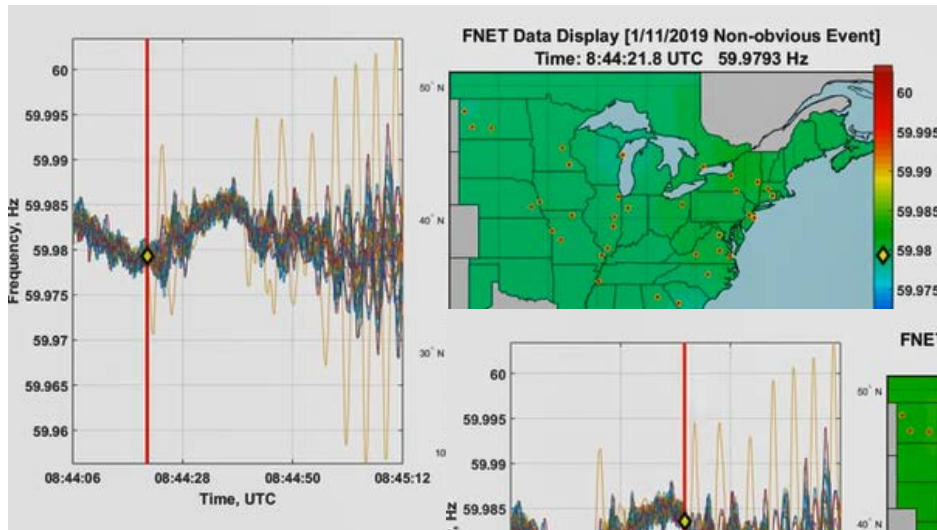
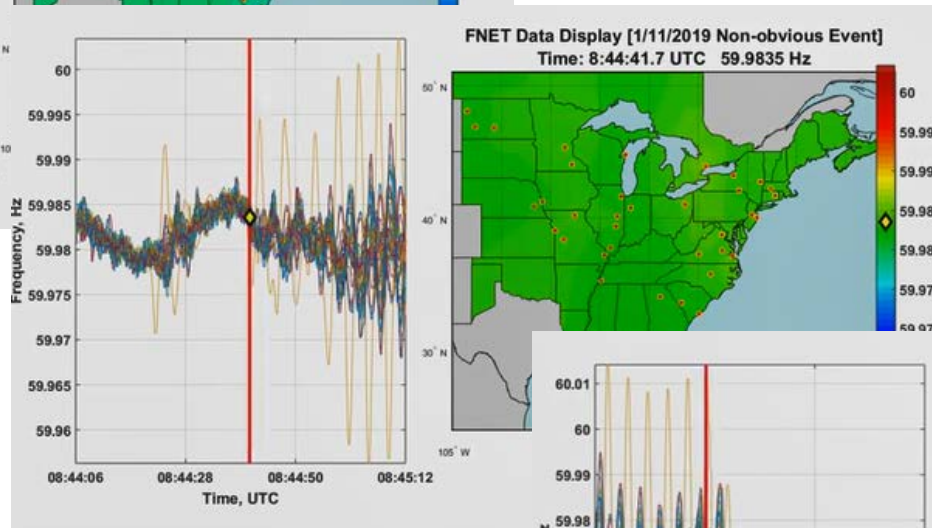
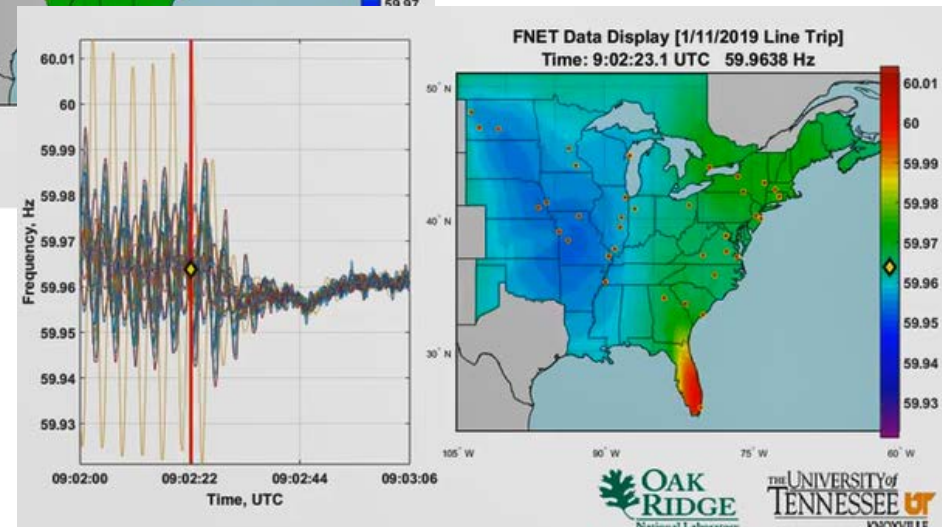
- Strange oscillation in Florida around 08:44:21 UTC (03:44:21 EDT)

- Oscillation strengthens at 08:44:41 UTC (03:44:41 EDT)
- Oscillation ends at 09:02:23 UTC (04:02:23 EDT)

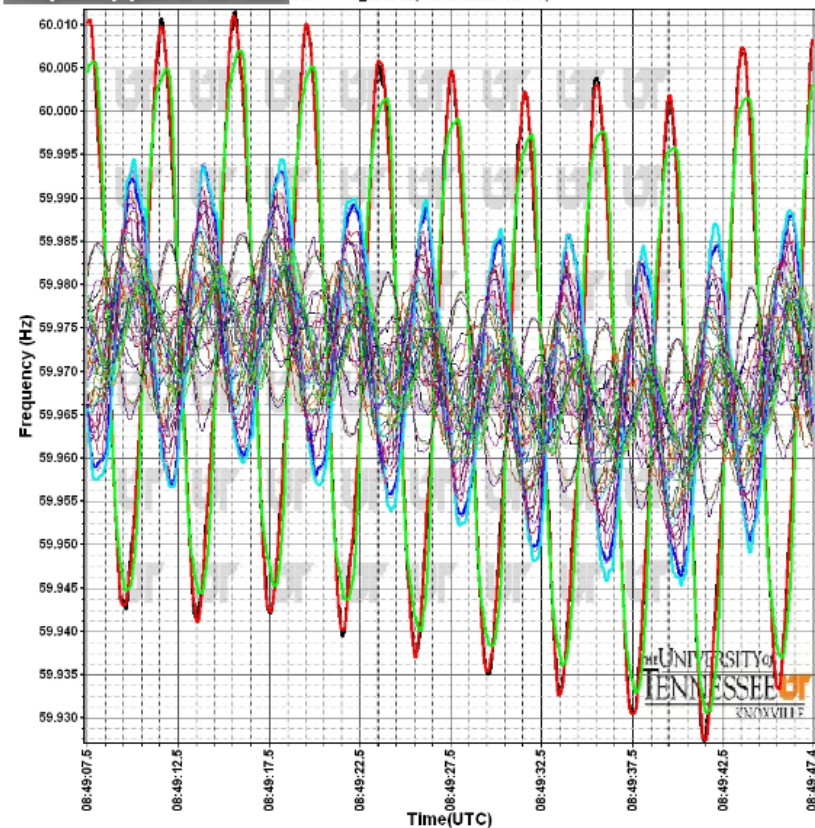
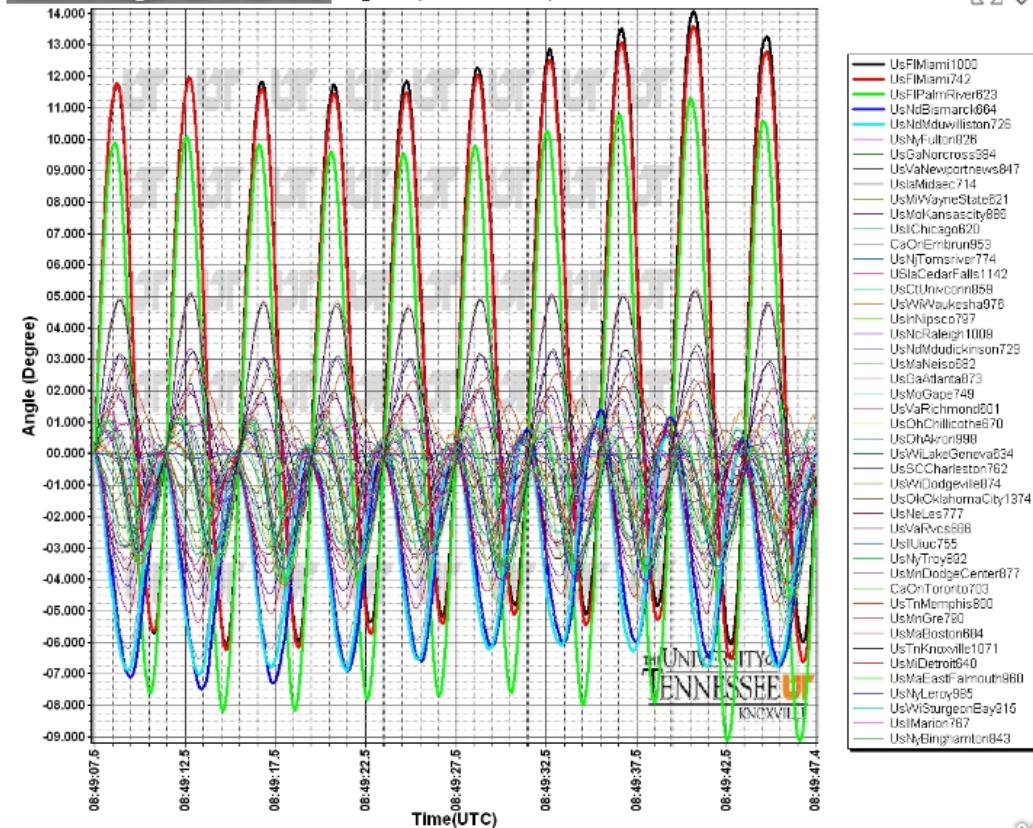
Mode #1: Frequency: 0.25 Hz, Damping Ratio: 0.16 %, Amplitude: 2.38 °

Frequency plot of All FDRs sci011119\_084912(Ref:UsIllMatton778)

Relative Angle Plot of All FDRs 1119\_084912(Ref:UsIllMatton778)

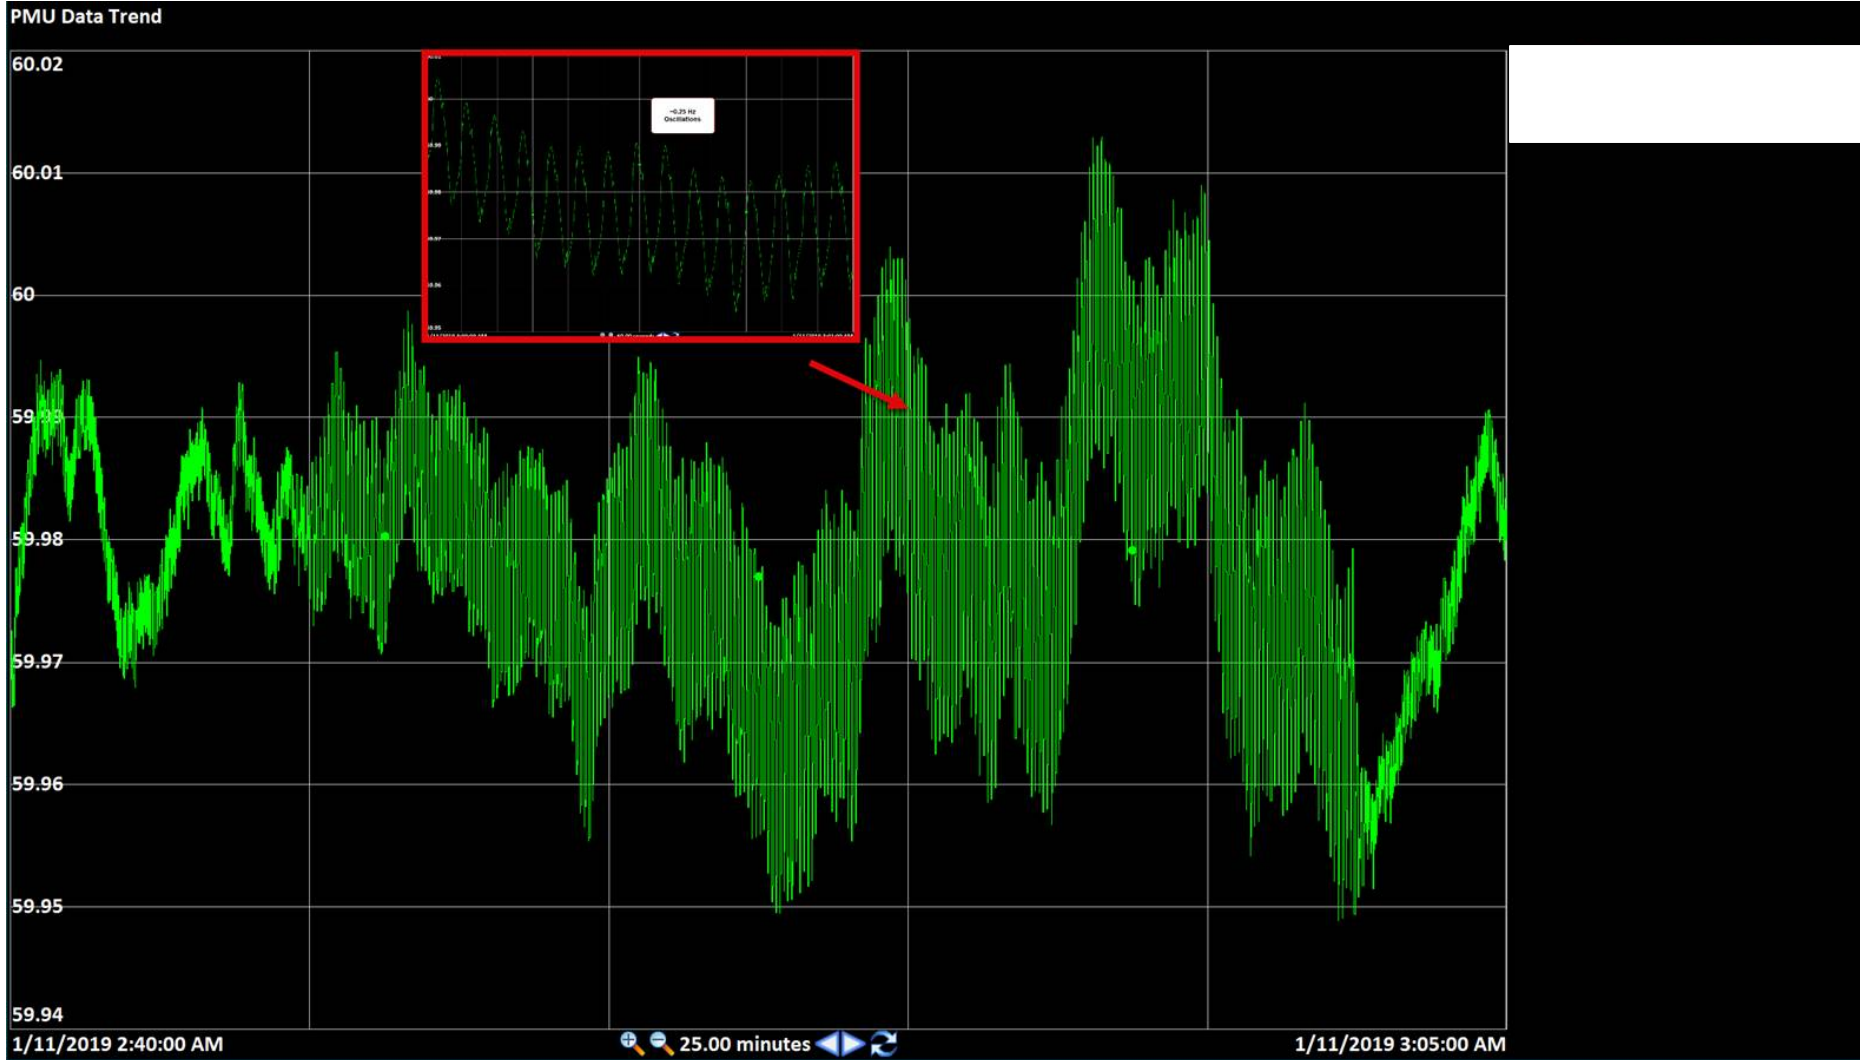
• Plot is sum of EHV lines connecting from Wisconsin to Illinois

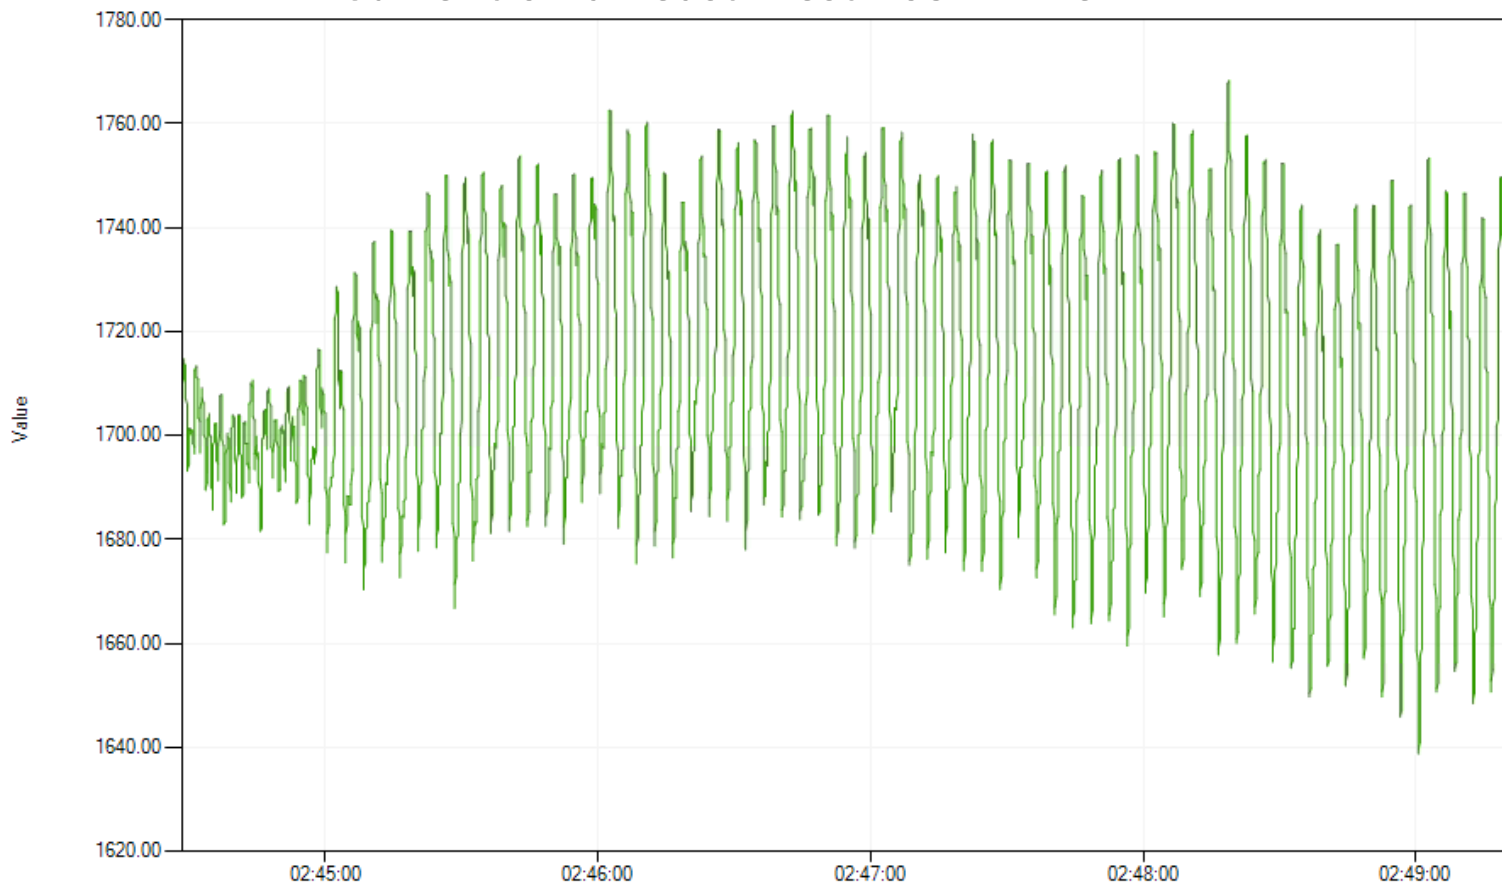
### Current on an east-west 765kV line

Start Time: 2019-01-11 02:44:28.370 End Time: 2019-01-11 02:49:22.407

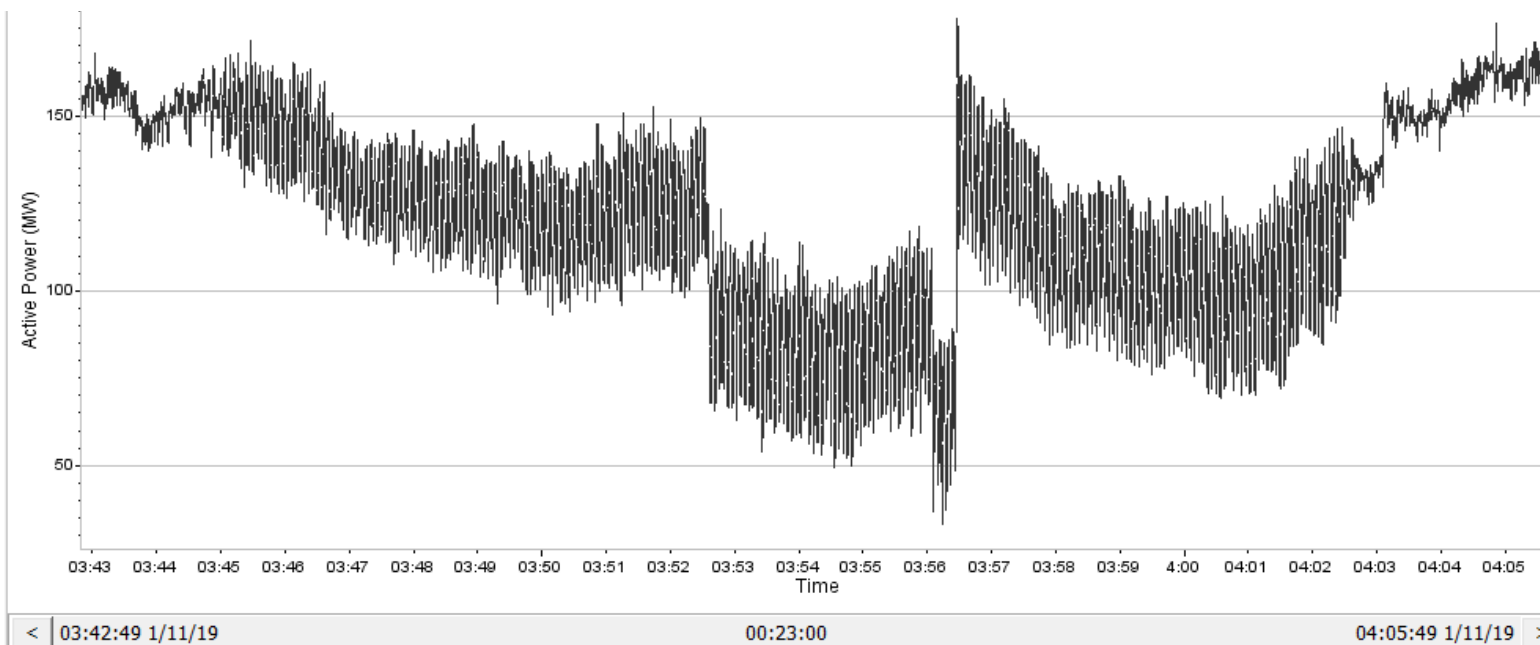
- ISO-NE Phasorpoint generated 14 alarms (20+ Alerts) from 3:46-4:03 AM, 0.249 Hz oscillation, magnitudes up to 10-15 MW RMS
- OSL application automatically processed Alarms and Alerts, identified source of oscillations located beyond ISO-NE area
- Plot: MW flow on 345KV line between NE and NY.

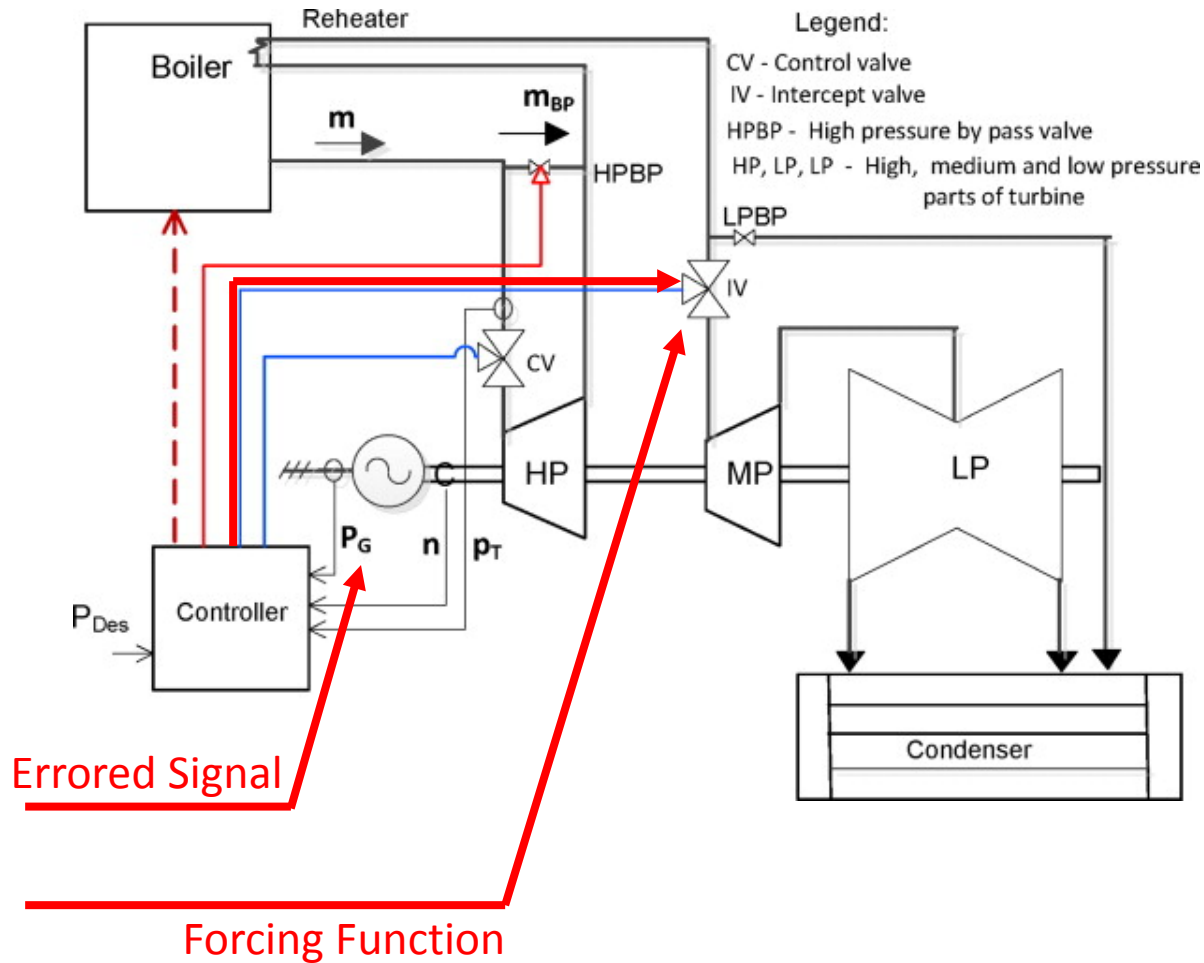
- Repowered combined cycle plant – steam turbine oscillating
- Power-load imbalance (PLI) controls
- Failed potential input feeding feedback
  - Feedback reading 2/3 power output vs. input – perceived imbalance
- Drives shut intercept valves
- 4 second timer to reopen valves – open/close cycle
- Different potential inputs for relaying and controls/metering
  - Relaying hence did not pick up the imbalance/issue
- Plant manually tripped by operator
- Upon inspection, failed wiring in PT cabinet
- Damaged intercept valves, needed replacement, unit off-line for relatively extended period (couple weeks)
