Recent BESS Oscillations: Root Cause Analysis and Wide-Area Impacts

NASPI Webinar, 7/10/2024

Matt Rhodes and Daniel Goodrich

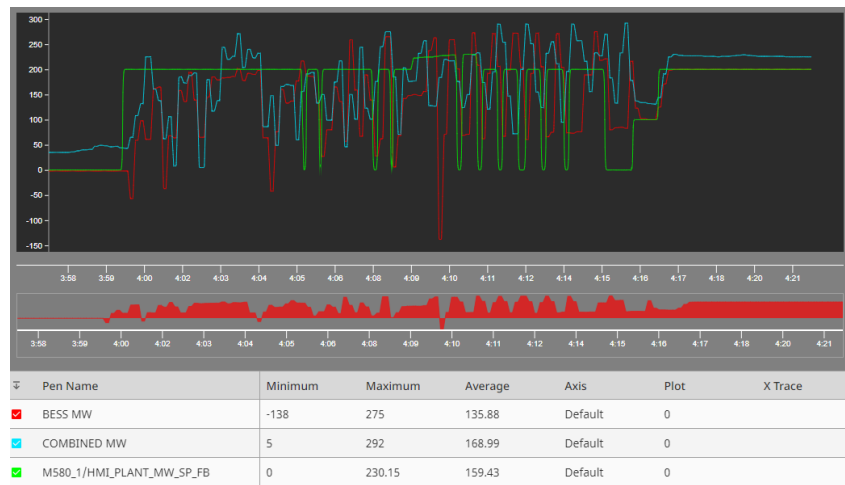
- Battery site was in an idle state when the site controller received a 200 MW discharge setpoint
- Site began to ramp but started oscillating prior to reaching the 200 MW discharge
- Oscillations lasted 17 minutes where maximum recorded output was 275 MW and minimum was -138 MW
- The site was placed in local mode with a 200 MW setpoint and followed that dispatch stopping the oscillations

Significant power output swings observed after site responded to discharge dispatch instructions

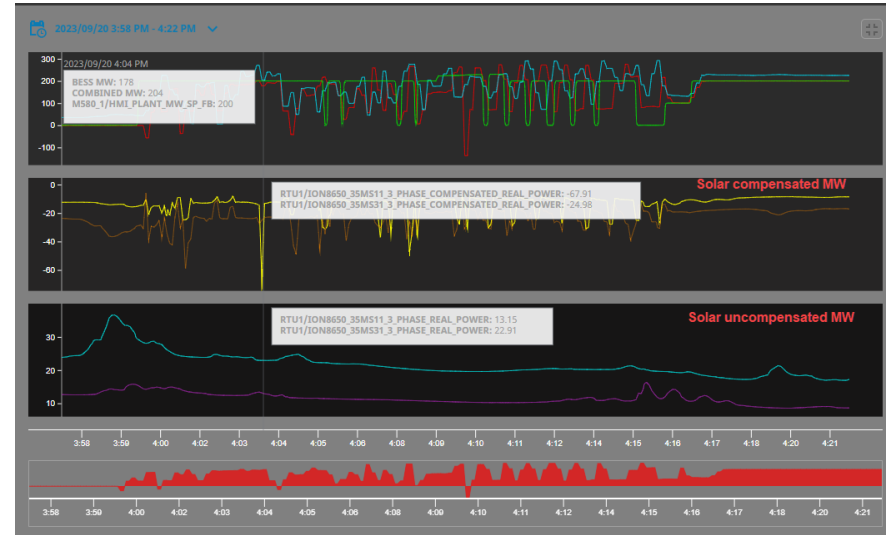
- The metering EOR developed an algorithm to calculate losses for solar production when solar was passing through the transformer even when solar was charging the BESS
- This algorithm was approved by the operator and SRP and was tested by the operator with passing results
- The oscillation proved the compensated MW values were not plausible
- It was determined under certain conditions the algorithm would cause a divide by zero error that greatly increased the compensated MW values beyond the actual MW capacity of the site.

Under certain conditions, the algorithm used to calculate losses on the solar production caused a divide by zero error resulting in oscillation

- On 9/24 the loss compensation logic was disabled in the meters for the solar charging BESS conditions
- New loss compensation logic has been written to eliminate the divide by zero scenario which has been approved by SRP and is currently being implemented by the metering EOR
- PLC compensation block will be revised to match the meter logic
 - Then, the PLC will control the power based on compensated power values

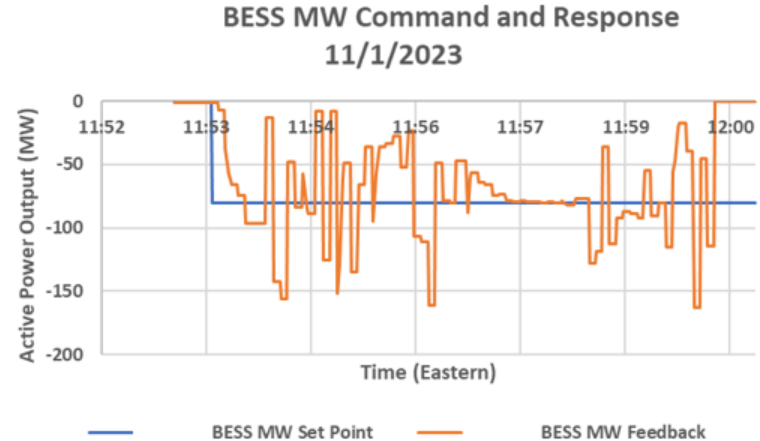
- Battery site was dispatched from a 0 MW setpoint to 80 MW charge at ~11:53 EST on 11/1/2023
- Site ramped to -80 MW and began oscillating, with maximum output of ~-8 MW and minimum of -160 MW
- Adjacent PV site under commissioning and was injecting power at time of event

Significant power output swings observed after site responded to charge dispatch instructions

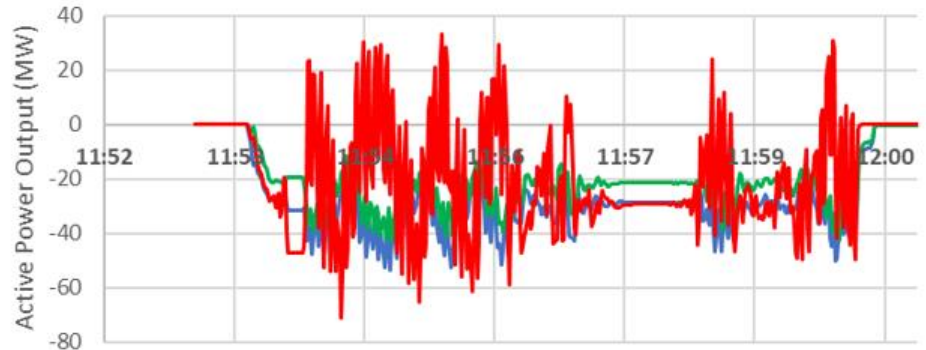
**BESS Sum of Inverter MW
Output: GSU 1, 2, and 3 - 11/1/2023**

- Site had control system update pushed on 10/31/23
 - Adjusted Ymin/Ymax values that reduced maximum and minimum values that can be commanded from site controller
 - Update was done by taking PLC offline and restarting controller
 - Not standard update practice for operating units
- Oscillation was not consistent between the 3 site GSU transformers
 - GSUs 1/2 showed similar behavior, GSU 3 had more aggressive output swings

Inconsistent output swings observed across different portions of the facility. Differences in response between GSU Transformers indicate issue was not created by site level PID control, but with GSU-level translation of site commands

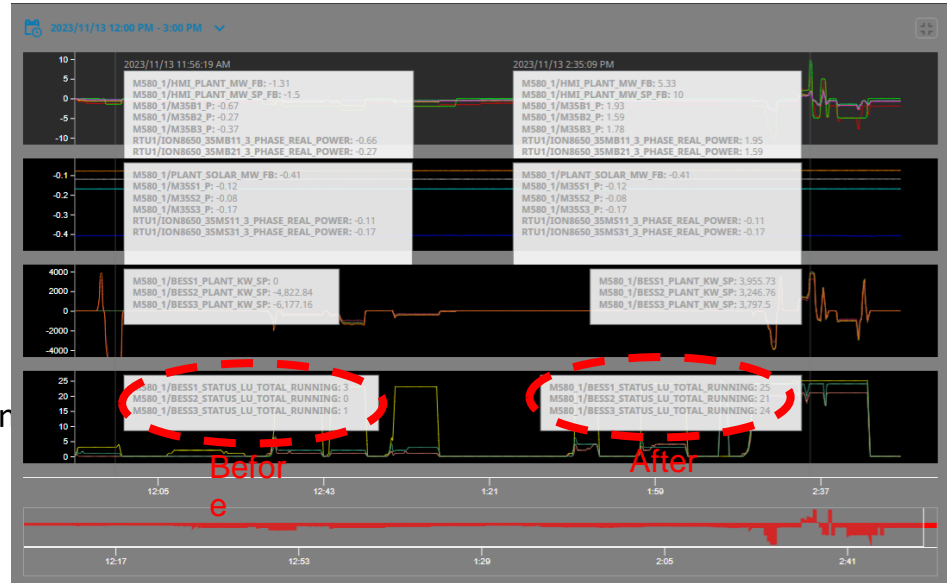
- The control update from 10/31/23 created condition that required all inverters on site to go through extended start sequence
 - Likely resulted in portions of the site waking at different times, creating an unbalanced condition that could shift load to specific portions of the facility
 - Testing confirmed asymmetric starts between transformers

Differences in response between GSU Transformers suspected of driving GSU near MVA limit

- Updated GSU MVA protection logic to prevent MVA remaining value from going negative
- Corrected code inconsistencies for idle stop and inverter reset across site PLCs
- Standardized values for Ymin, Ymax, and automatic/manual transition across site PLCs

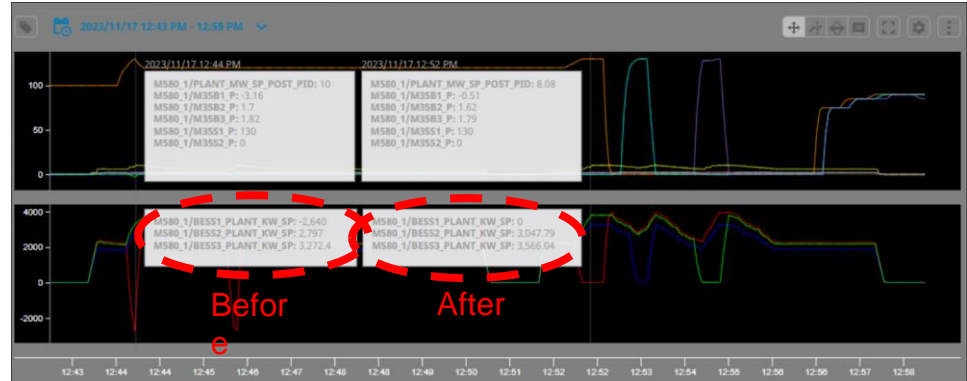
- Controller programming differences between GSUs revealed vulnerability in the code that translates site-level commands to inverter-level commands
 - When a GSU approached the specified MVA limit, it allowed for improper instructions to lineups to transition to discharge from charge (or vice-versa)
 - Testing confirmed disagreement of output that was consistent with behavior of GSU 3 during event

Differences in inverter-level setpoint command logic allowed inappropriate setpoints to be communicated to some inverters on site. The response of the remainder of the facility creates conditions for a sustained oscillation event.

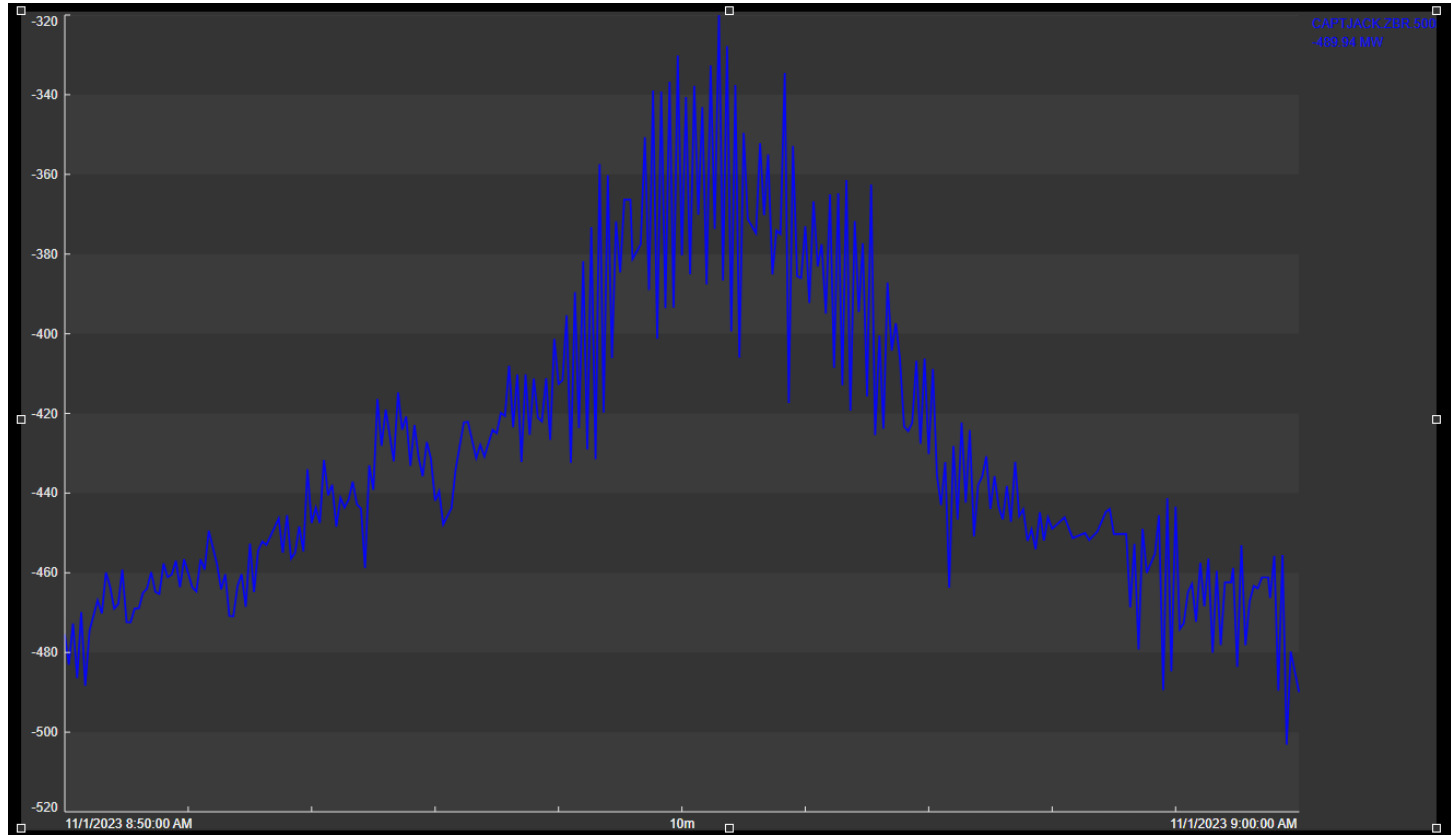
Fluctuations on 500 kV line

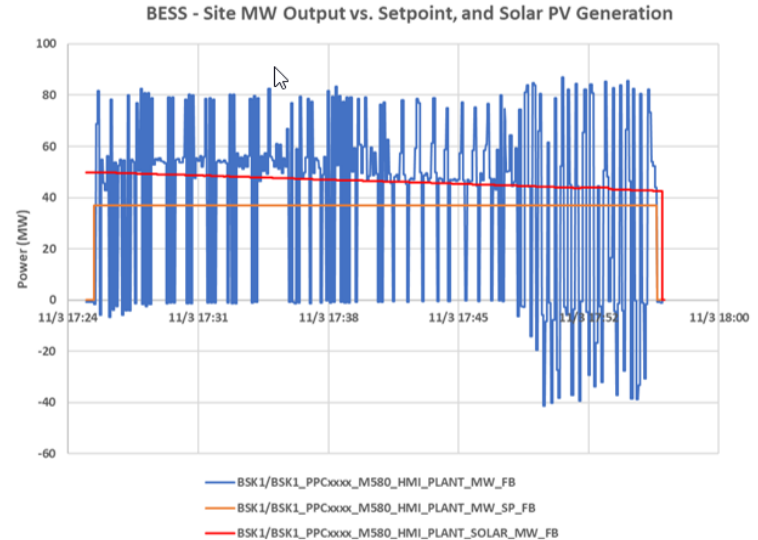
- Battery site was dispatched from a 0 MW setpoint to 37 MW discharge at ~17:25 EST on 11/3/2023
- Site output immediately began oscillating, with maximum output of ~85 MW and minimum of -40 MW
- Adjacent PV site under commissioning and was injecting ~50 MW at the time of event start

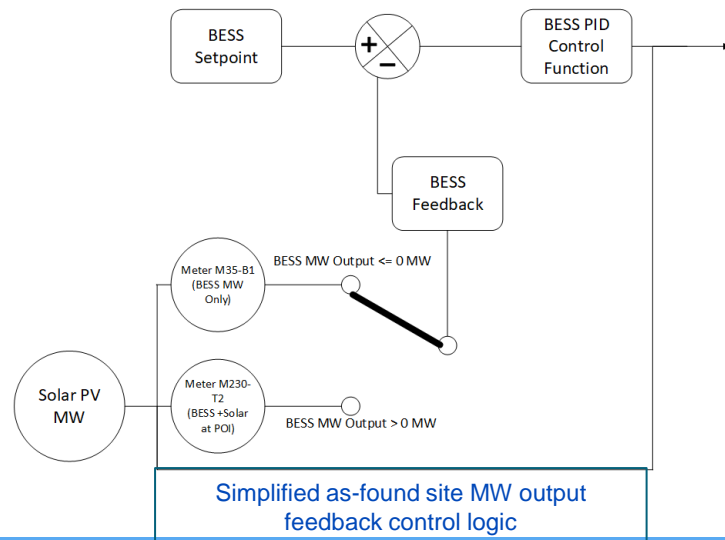
- Battery MW output value that is fed back to PID loop is dependent on if the site is charging or discharging
 - Discharging logic must include solar contribution to prevent interconnection limit violations
- Solar PV output was not yet added to metering scheme
 - Resulting in the controller misinterpreting the measured value as if the BESS site was exporting too much power when that meter source was selected

The dispatch period on 11/3 was the first instance of a BESS site command for a discharge value that was less than PV actual output

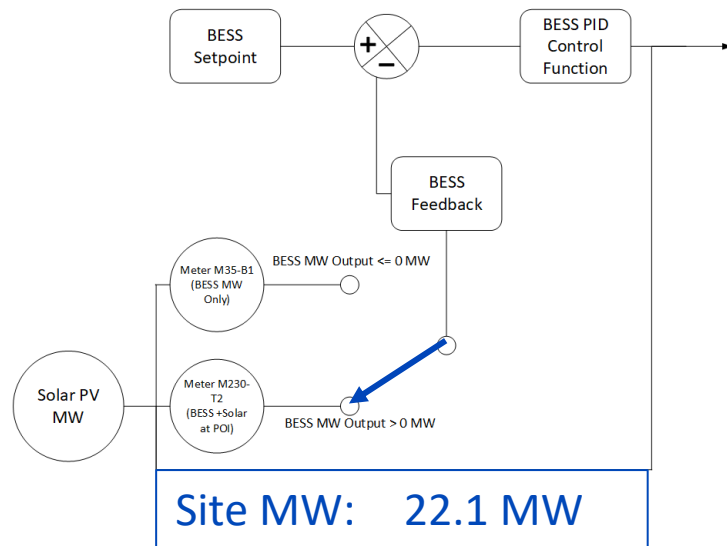
Battery site discharging against unachievable command

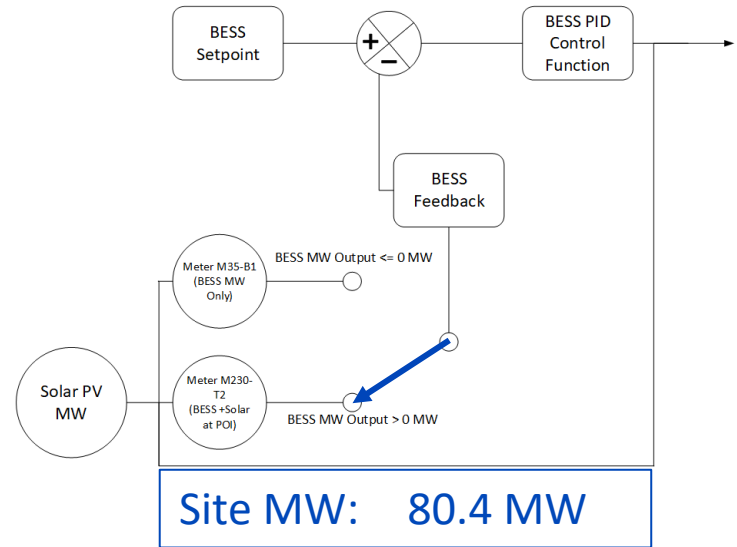
Battery instantly over-discharges, output control adjusts

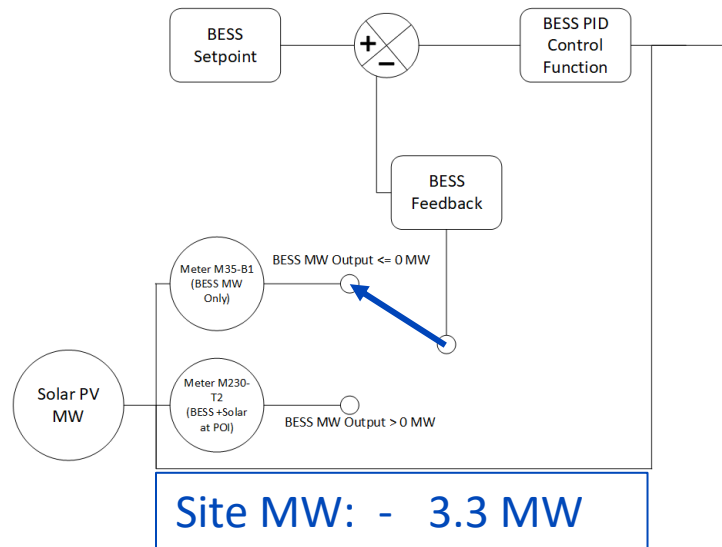
Battery output begins increasing output and will overshoot

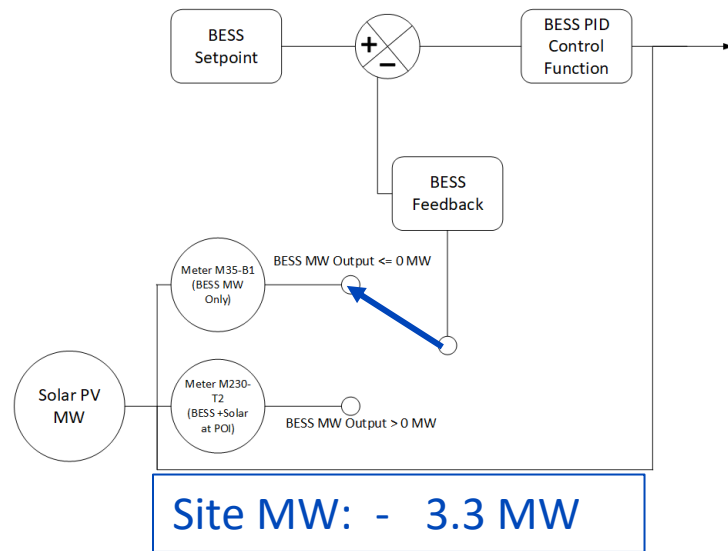
Oscillating MW response will continue until either site is stopped, or MW setpoint to battery is above solar output/below or equal to 0 MW

- **Root cause 1: Forced parameter set to zero from time of BESS site commissioning on solar PV MW Meter**
 - For oscillation to occur, site needed a BESS Setpoint >0, and less than solar actual output. 11/3 was first time this condition occurred

- Short-term: Force PID feedback to only one source (BESS GSU low-side metering)
- Long-term: Add Solar PV into BESS site MW feedback function
 - Validate countermeasure applied at all co-located Solar / BESS facilities under construction

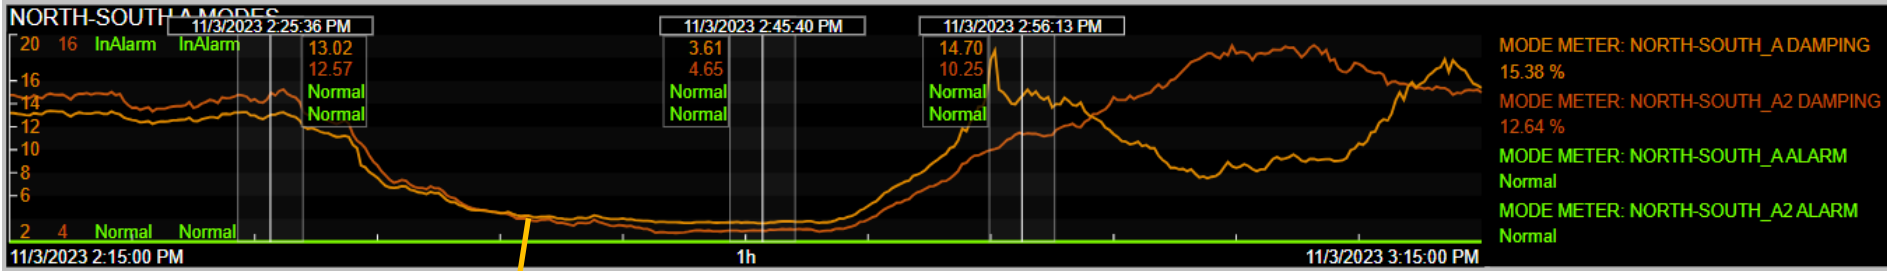
Damping Drops, but does not get below 2%, thus no alarms
