NASPI Webinar

Preparing for the December 31, 2016 Leap Second

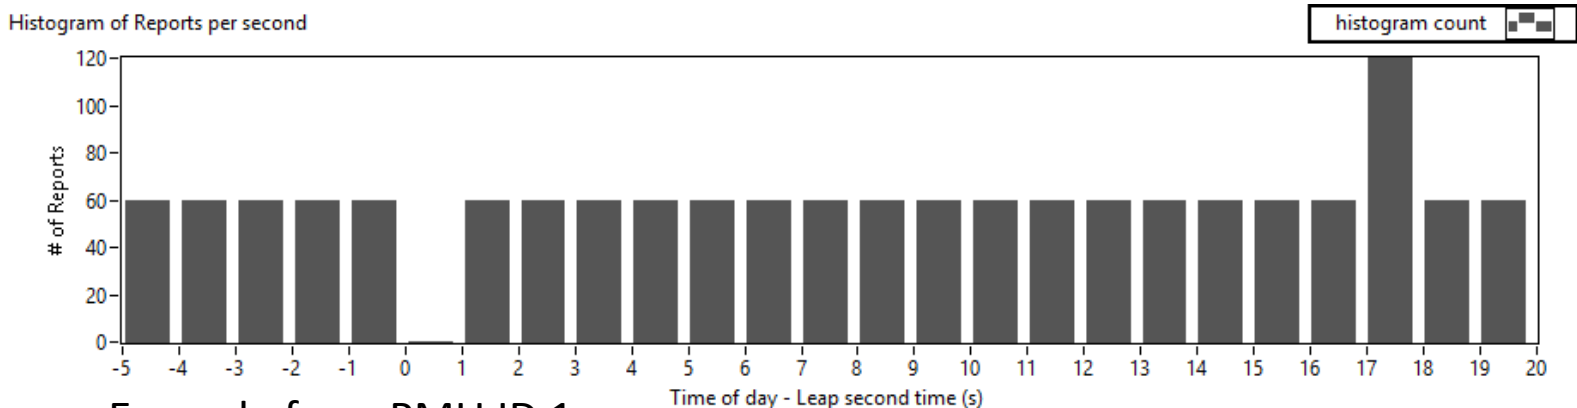
Example from PMU ID 1

- “Missing” reports (the time never happened)
- “Duplicated” reports (reports that should have had a different time stamp)

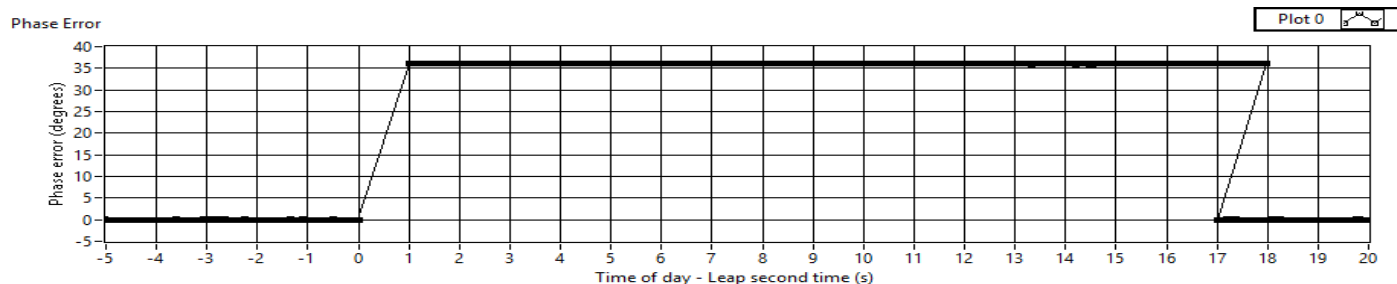
Again, an example from PMI ID 1

- For 17 seconds, it appears like the phase has a 36 degree error (at 59.9Hz)
- Note that there are no reports for the second immediately following the leap second
- And there are two sets of reports for the second between 17 and 18 seconds after.

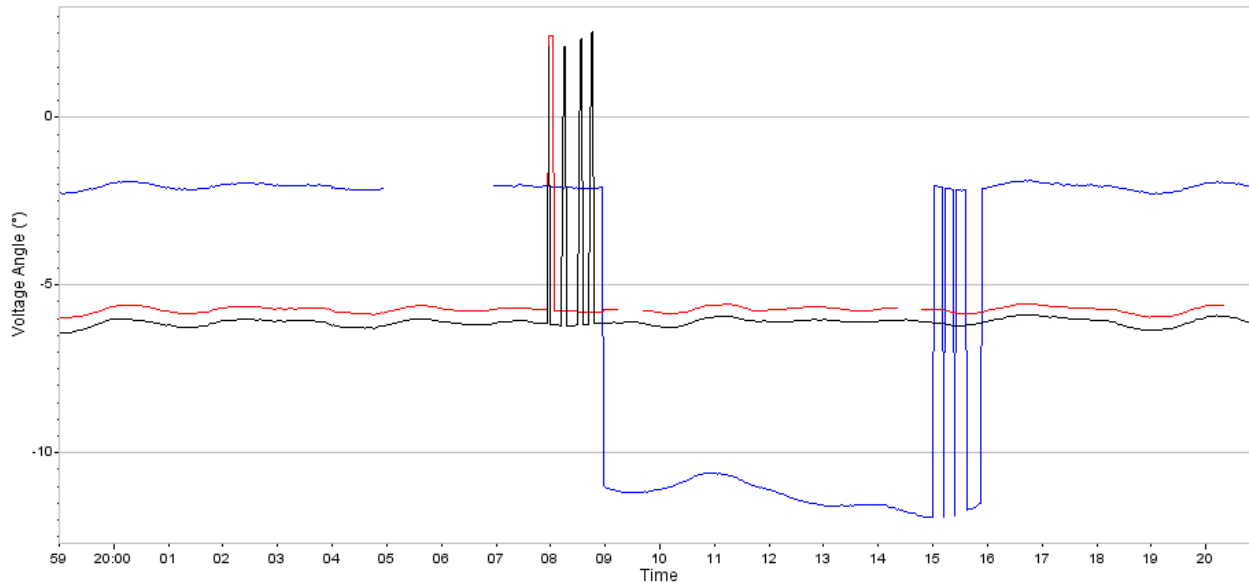
- Late leap, missing data, back and forth jumps.

Red and **black** data are from same clock/PMU make/model

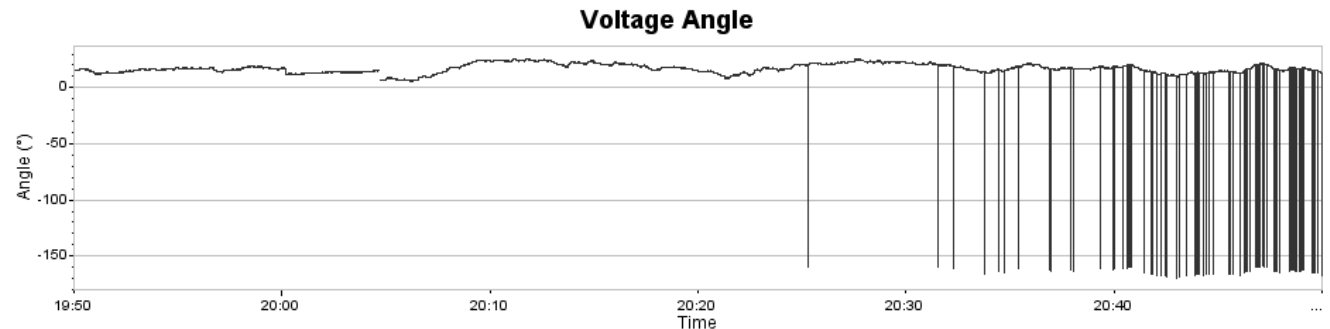
- Unstable

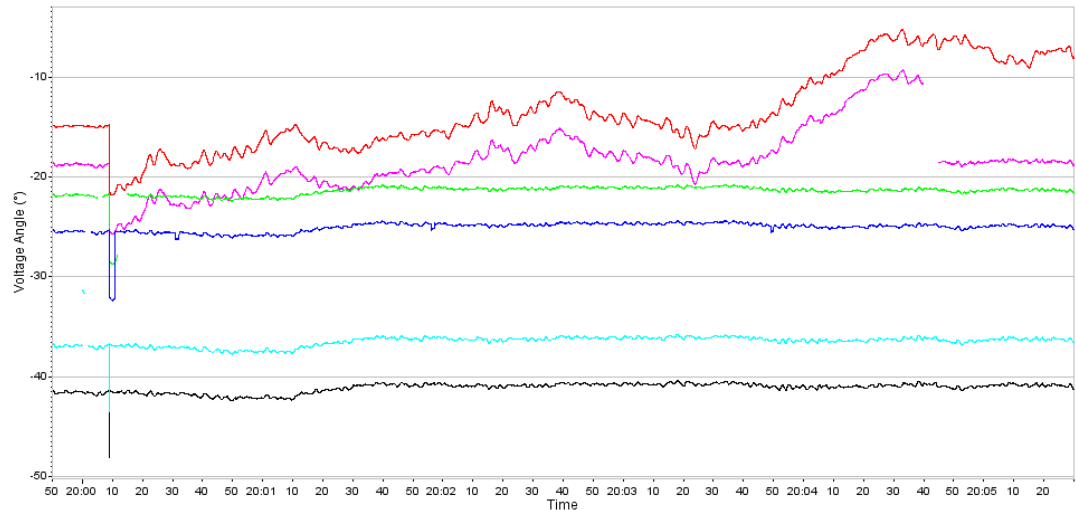
- With no leap second in time records
 - Angle jumps across the leap second
 - Fake **dynamics** – not an event!
- Leaped at different times
 - **Voltage angle difference changed**
 - No problem for **steady state** analyses if leaped at the same time
- Good news!
 - P & Q remain intact
 - Same change in VA and IA in the same PMU

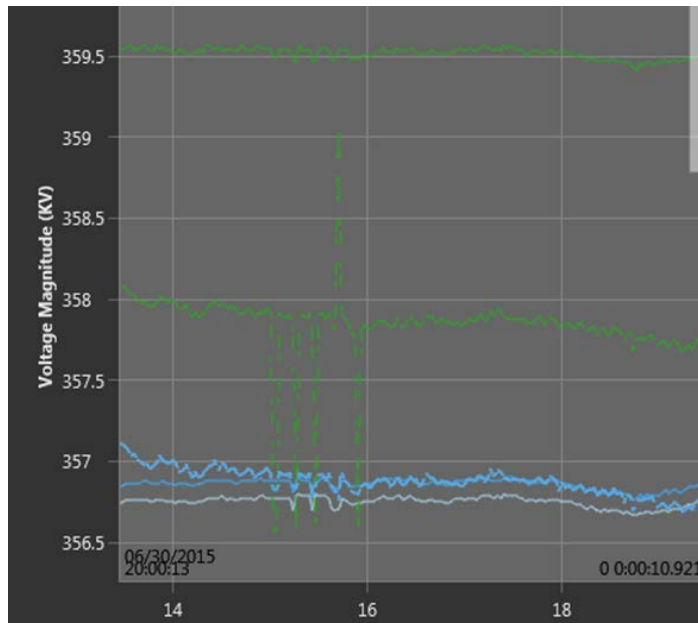
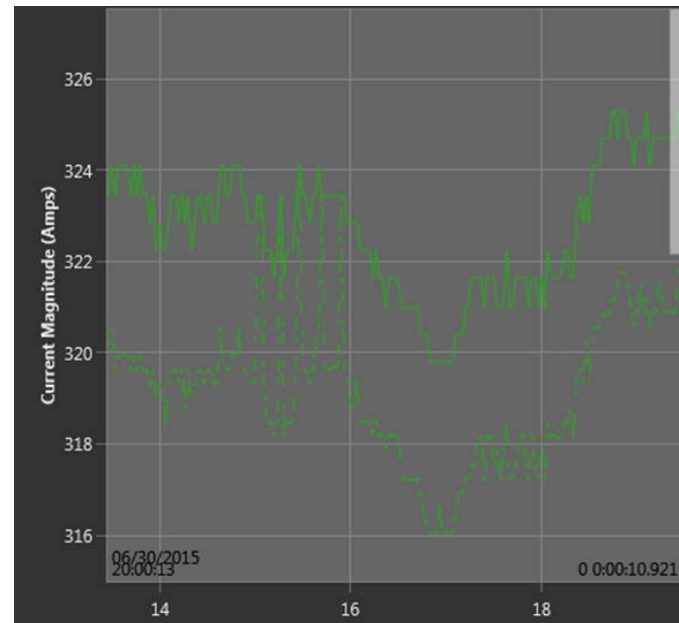
- Linear State Estimator
 - Affects the estimation results
 - Solid lines are raw data, dashed lines are estimated values
 - Errors propagated to magnitudes
