Spain Outage

Presented By: Theo Laughner, PE

- On 28 April 2025, at 12:33 CEST, the power systems of Spain and Portugal experienced a total blackout.
- The following slides shows measurements collected by a distributed IOT sensor network. The sensors were connected in home electrical outlets.
- Voltage and frequency were captured for several hours prior to the grid failure at approximately 10:30 UTC.

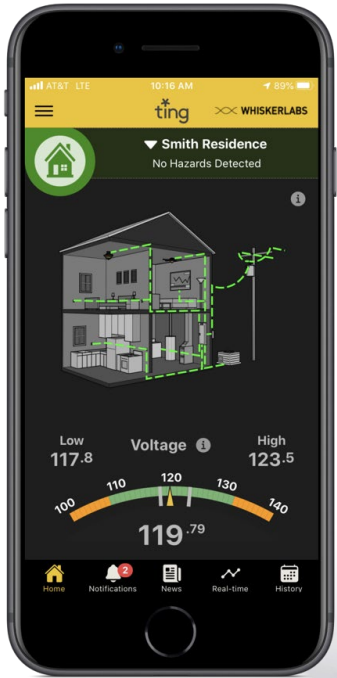
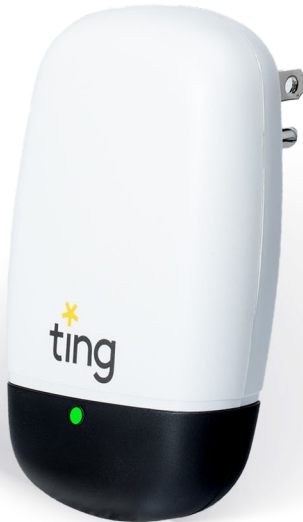
Sophisticated AI and machine learning platform measuring:

- * Voltage
- * Frequency
- * Total Harmonic Distortion (THD)
- * Arcing

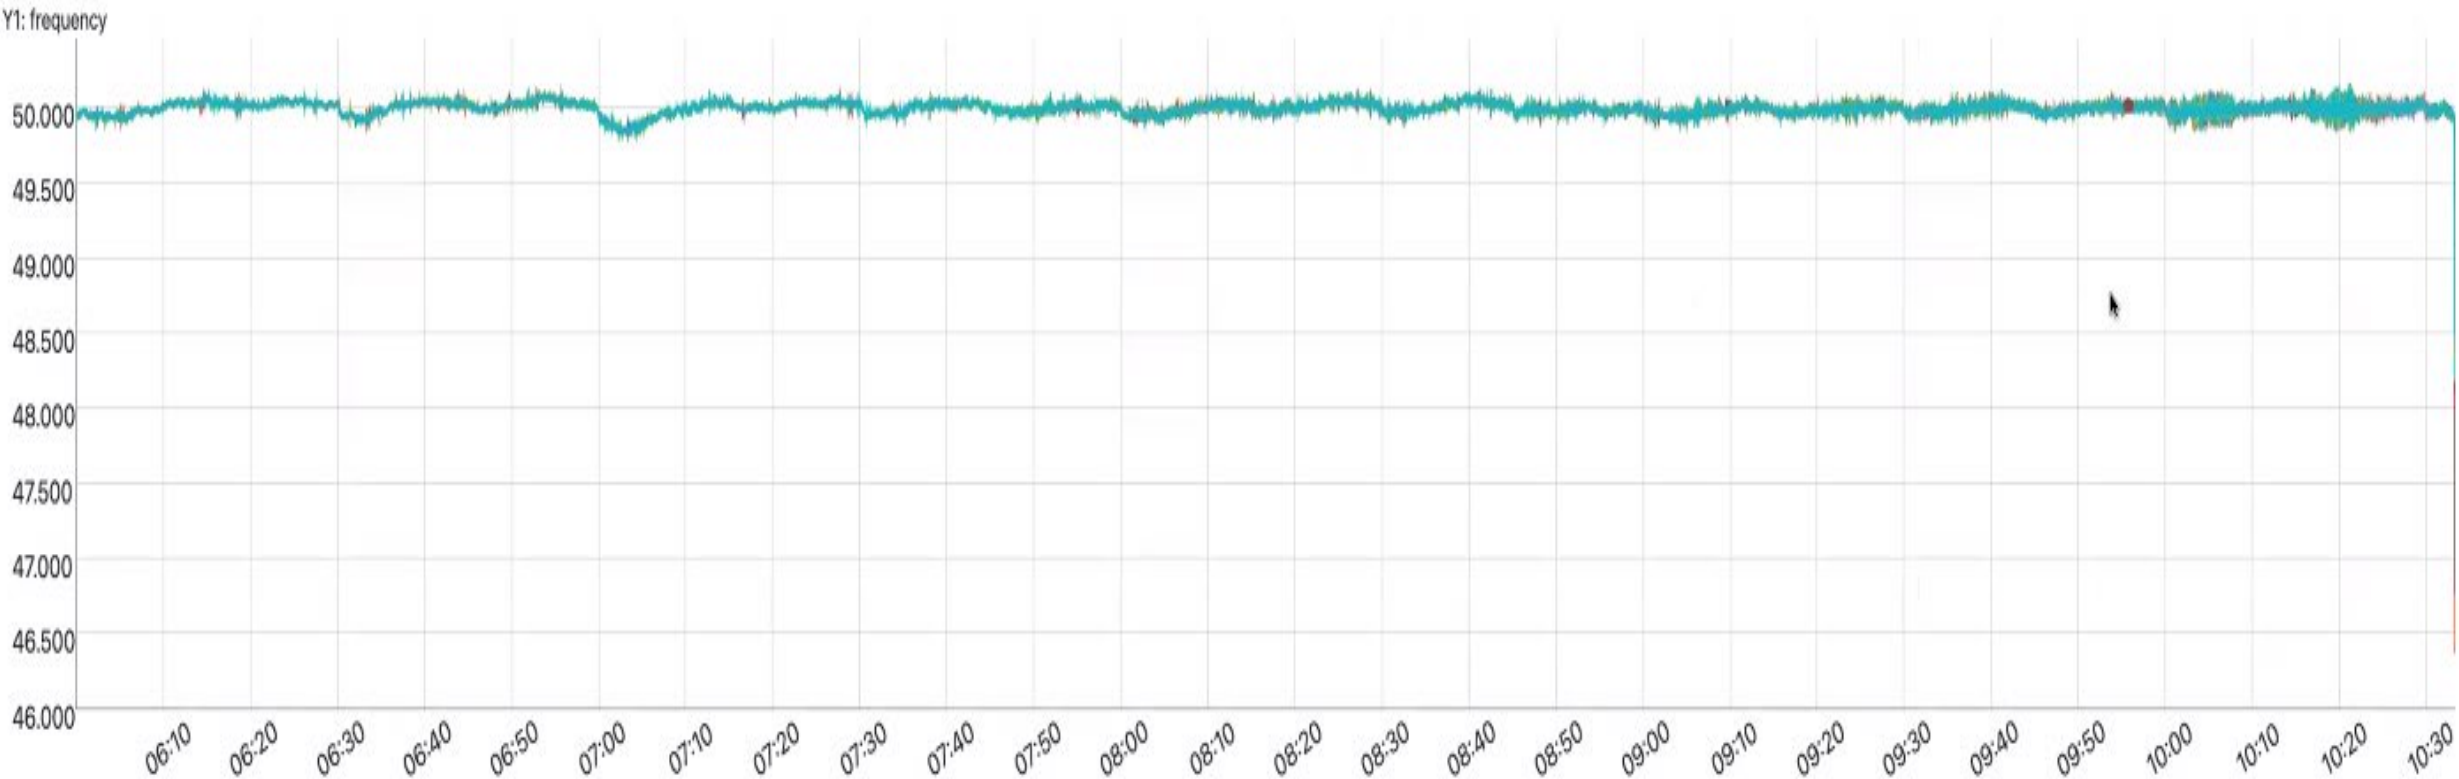
Spain Outage - Frequency

Whisker Labs Summary Plotter for Mon Apr 28 2025

- 12:33:18 – 12:33:21 CEST** – grid frequency of the Iberian Peninsula drops below 48.0 Hz. Automatic load shedding is activated.
- 12:33:21 CEST** – AC lines between France and Spain tripped.
