# Washington, DC Area Low Voltage Disturbance

April 7, 2015

NASPI Working Group Meeting

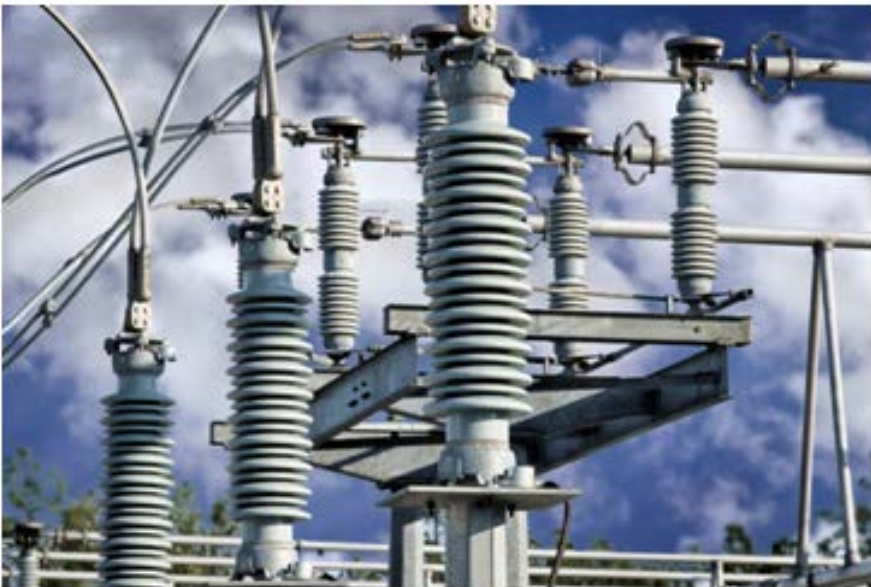
# Anatomy of a Surge Arrester

Lightning (surge) arrester is a device used on electrical power systems to protect the insulation and conductors of the system from the damaging effects of lightning. When a lightning surge (or switching surge, which is very similar) travels along the power line to the arrester, the current from the surge is diverted through the arrester, in most cases to earth (ground).

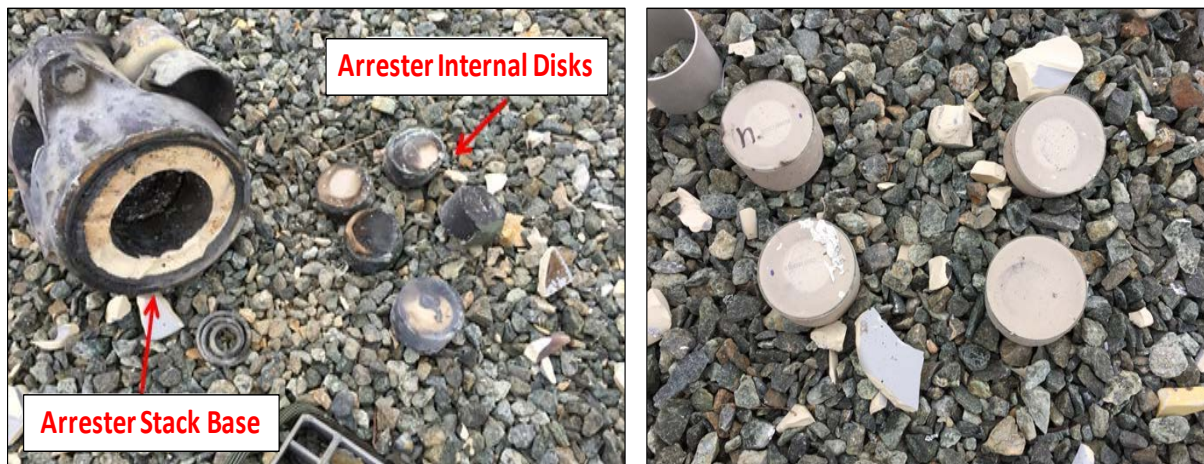
- No evidence of vandalism, sabotage, or cyber-attack in the event – verified by post-event forensic analysis
- Revealed significant burning to the C-Phase arrester
  - Consistent with electrical damage
- No evidence of burning to A-phase arrester
  - Suggests mechanical failure as a result of the arc burning off the insulator and the weight of the line breaking the arrester free from the structure

Internal MOV Disks from C-phase (left) and A-phase (right) Arresters

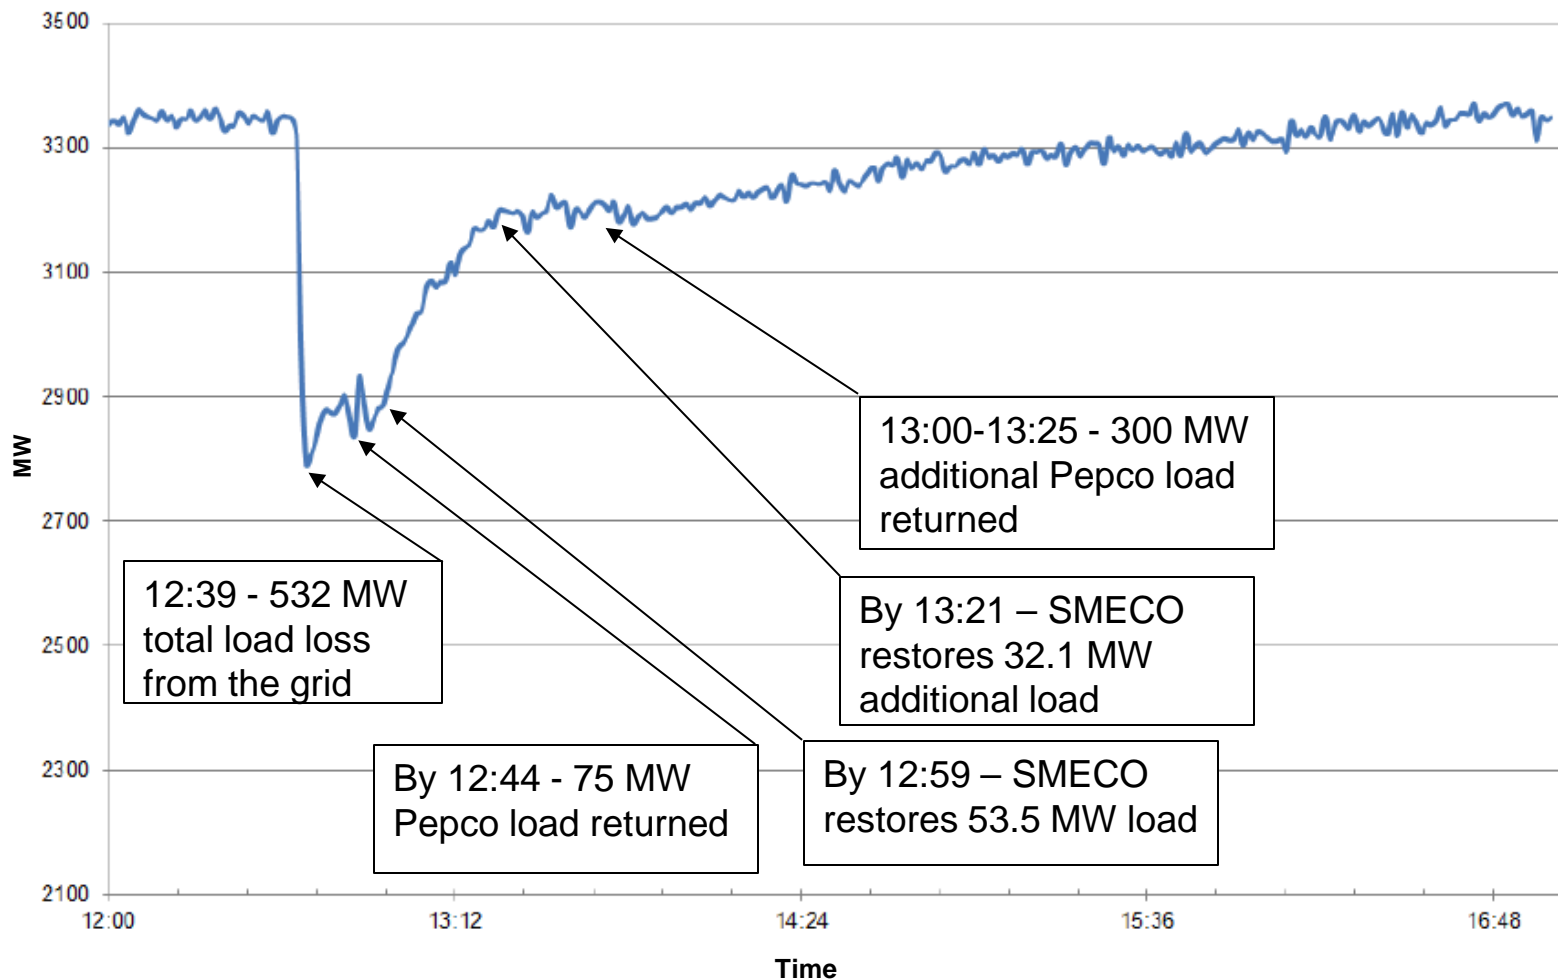
## Pepco Net System Load during 23072 Event

(includes SMECO load)

12:00-17:00 4/7/2015

- Pepco – 445 MW load lost, 71 customers power lost
  - 75 MW returned by 12:44, due to automatic systems
  - An additional 300 MW returned by 13:25
  - Remaining load was restored to meet demand
- SMECO – 87 MW load lost, 74,086 customers power lost
  - 53.5 MW returned by 12:39 via remote switching
  - An additional 32.1 MW returned by 13:21
  - Fully restored at 14:21
