Utilization of Synchrophasors during Synchronization and Operation of Large Grids - Experience of Indian Grid Operator

14-15 October NASPI Work Group Meeting, Chicago,IL

Case Study 1 : Synchronization of Large Grids on 31st December 2013

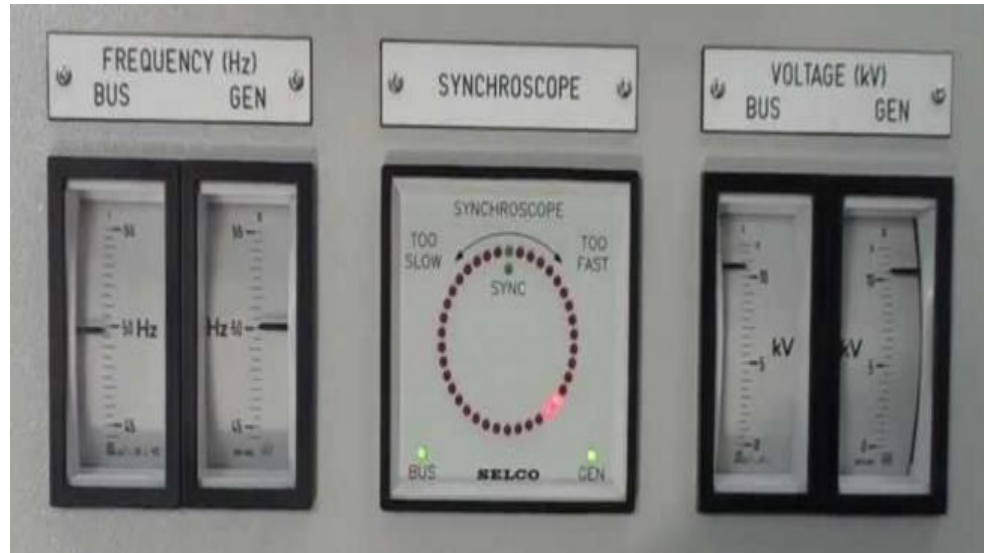
Synchronization Display in Field

Source : Holland-Controls QuickSync

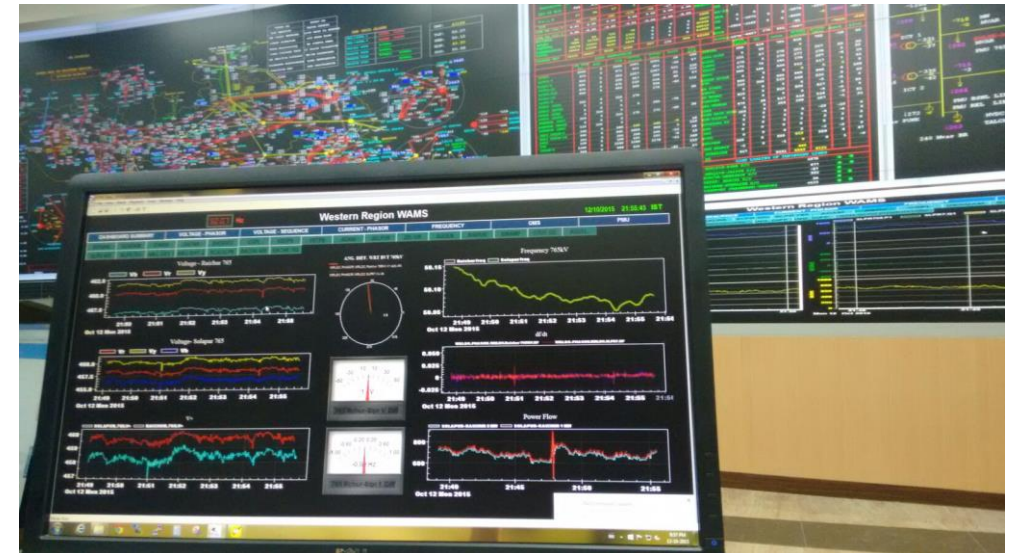
Synchronization Display at Control Centre

Remote Synchroscope for Control Centre using Synchrophasors

- PMU installed on both ends of the Tie Line
- Bus PT and Line CT given as input to PMUs
- Optical fiber communication between PMU to Regional Control Center.
- Displays for visualization / decision making
 - Frequency Control
 - Voltage Control
- Real-time view at Regional/National Control Centre
- Instruction for activation of auto-synchronization at sub-station issued from Control Centre

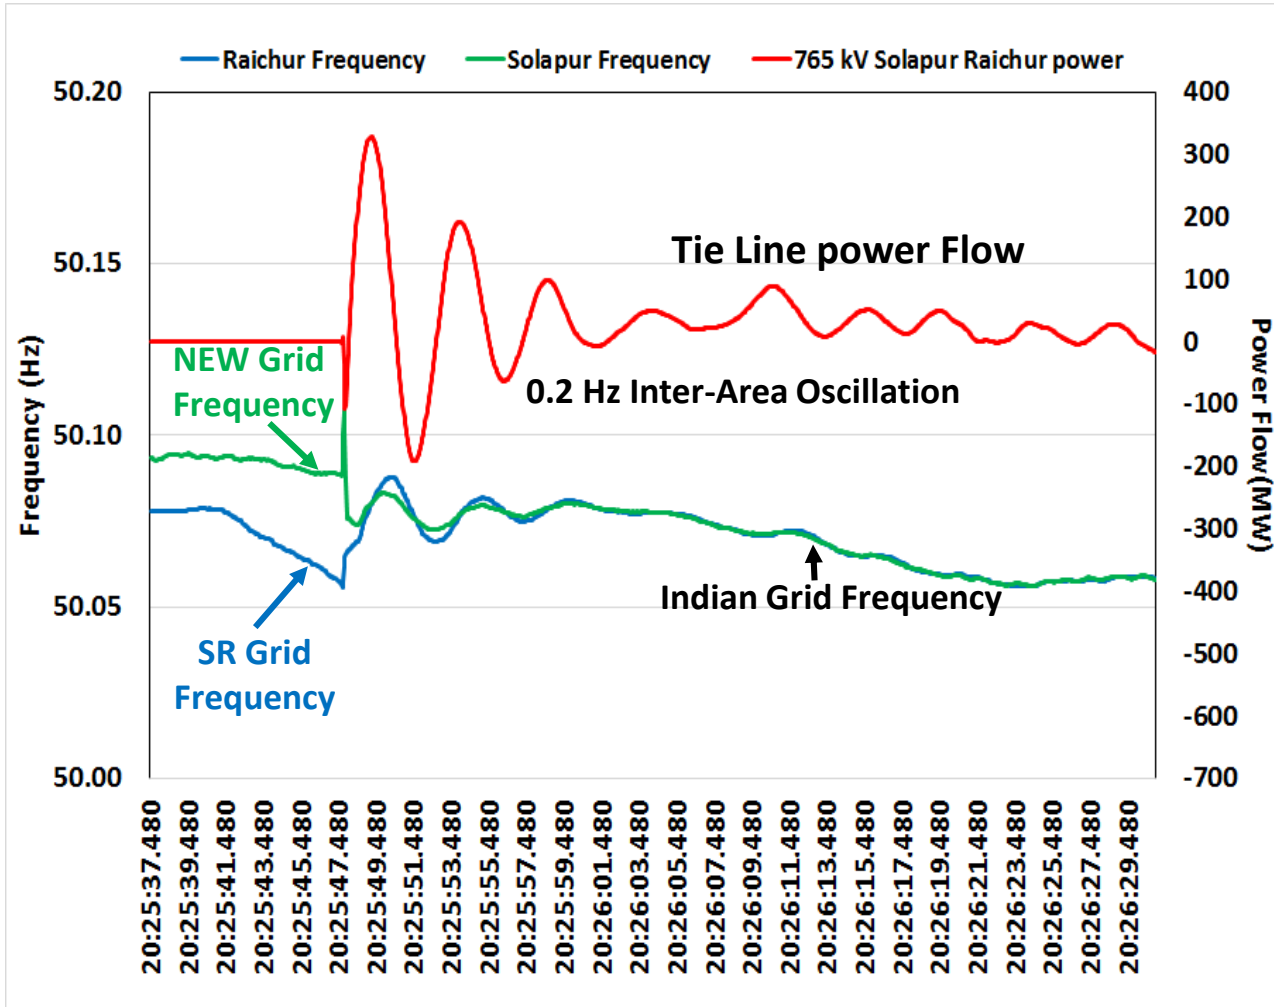
First Synchronization

- Frequency of NEW Grid higher than SR Grid.
- $\Delta f = \text{NEW-SR} = 0.039 \text{ Hz}$
- Max Power flow in First swing : 328 MW export from NEW Grid to SR Grid.
- Inter-Area Oscillation Mode detected : 0.2 Hz
- Oscillation damped out time : 16 sec.
- Synchronization Tool reused subsequently at 14 times.
