# ASSET HEALTH MONITORING USING SYNCHROPHASOR TECHNOLOGY

PRESENTATION FOR  
NASPI WEBINAR SERIES

NEERAJ NAYAK

January 24, 2024

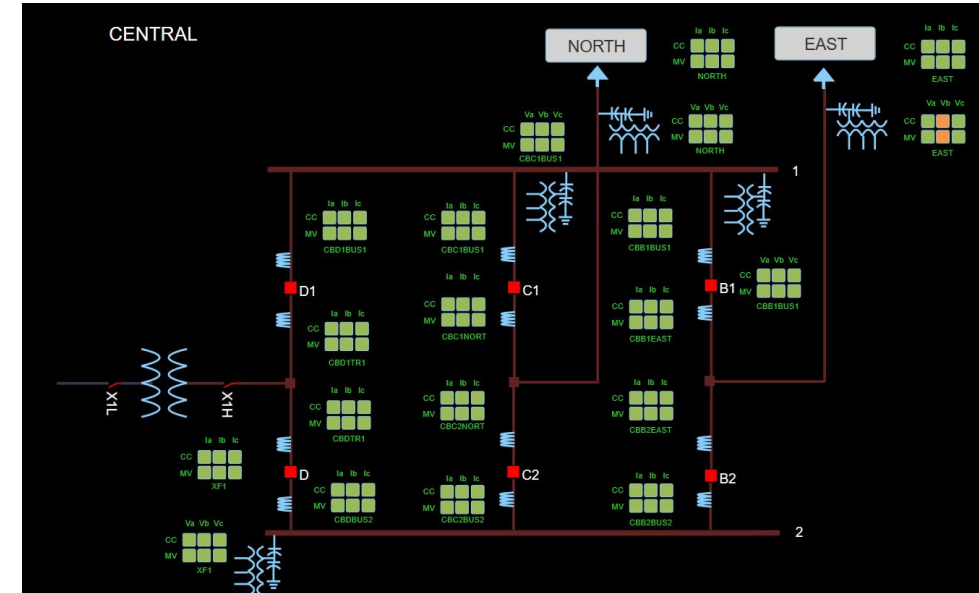
The screenshot shows an Outlook email interface. The email is from 'epg\_test' with the subject '[Alerting] Substation 1 Alarm'. A callout bubble points to the email title with the text 'CCVT Precursor Alarm Email'. Another callout bubble points to a button in the Grafana dashboard titled 'Link to Real Time Dashboard'. A third callout bubble points to a screenshot of the Grafana dashboard, labeled 'Screenshot of Real Time Alarm Dashboard'. The dashboard shows a table of alarm events and a line graph of a metric value over time.

Identify faulty equipment on substation one-line diagrams

- Email Provides Information on
- Substation effected
  - Equipment (CT, PT, CCVT) alarming
  - Faulty Phase
  - Metric violated (Voltage or Current)

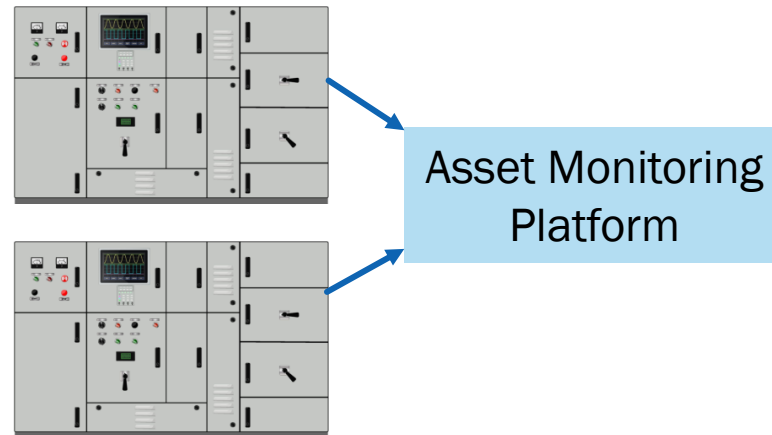
Standalone Asset Monitoring Platform  
– System Level

Deployed at a central location monitoring data from multiple substations

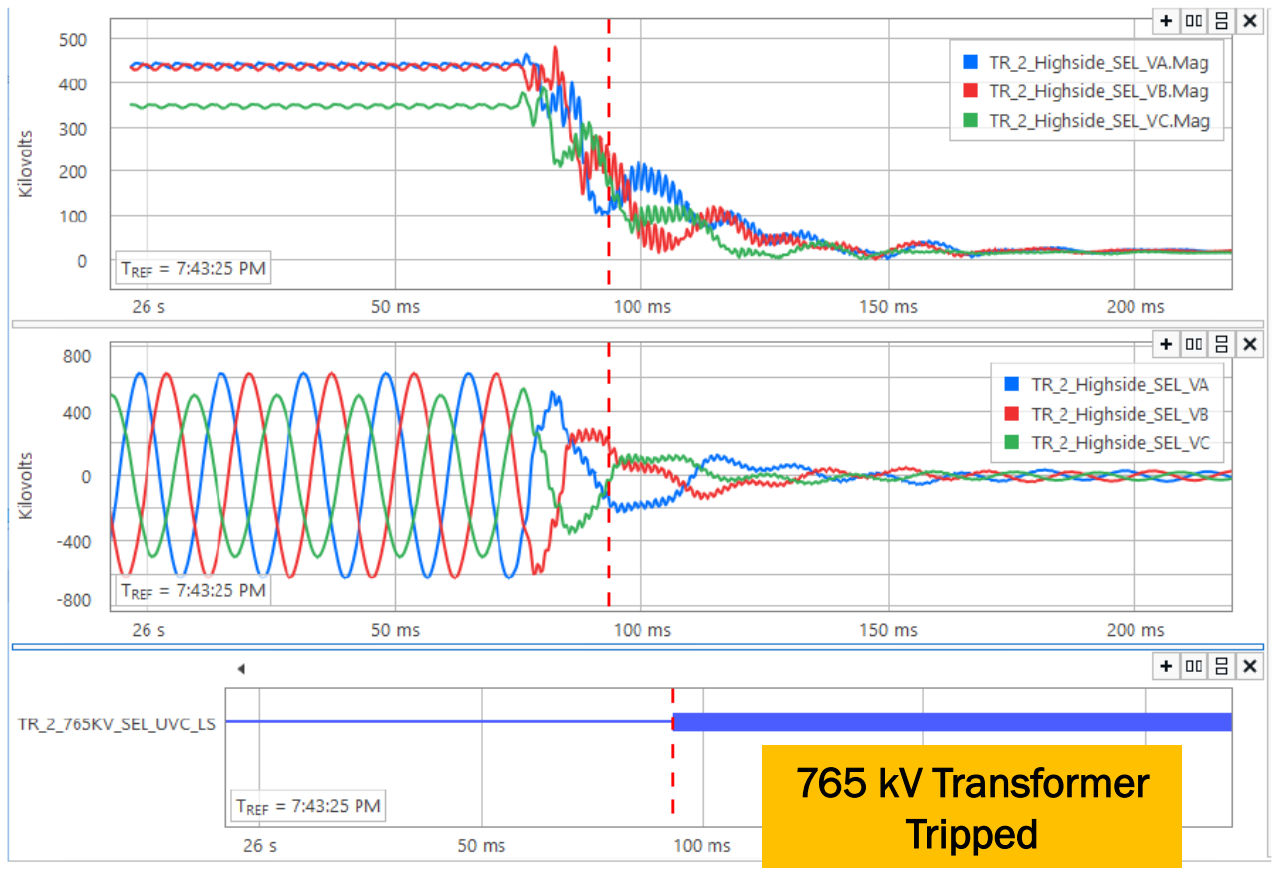
Capacitor failure in low voltage stack of CCVT

Precursors Observed ~ 5 Days Ahead

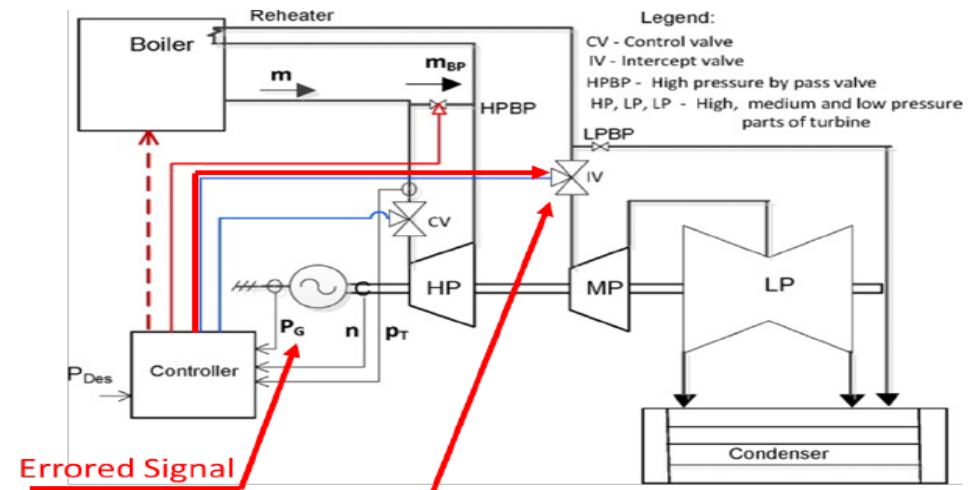
- NERC findings point to failure of PT connection that triggered Interconnection Wide Oscillations
- Forced Oscillation at a plant caused eastern interconnection wide oscillations with large amplitudes (> 150 MW peak-peak)
- Important to identify oscillations and locate source
- Important to identify and address root-cause to prevent system wide impact

Upon inspection, failed wiring in PT cabinet

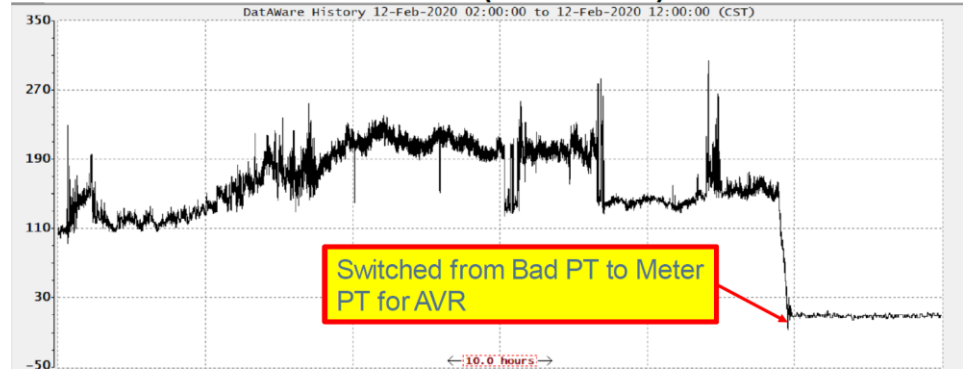
## Unit 2 MVAR – SCADA Data (2-12-2020)

Oscillations can reveal issues with asset/equipment
