# Diagnosing Equipment Health and Mis-operations with PMU Data

**NASPI Technical Report**

**May 1, 2015**

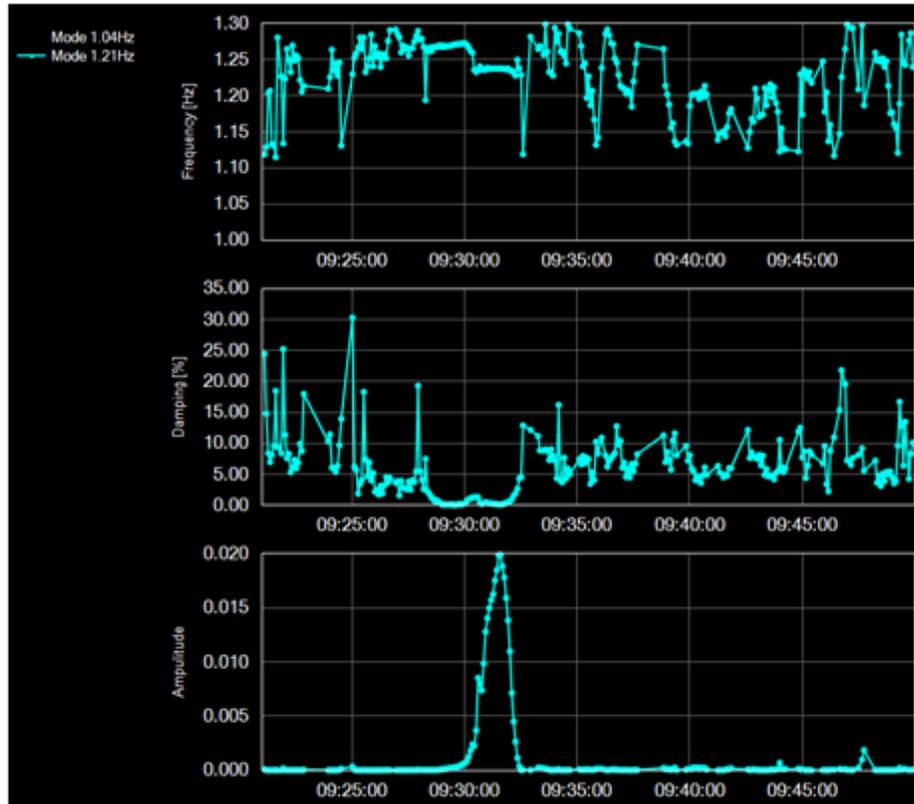
**Figure 11. Oscillation characteristics of power flow of the PMU closest to the oscillations**

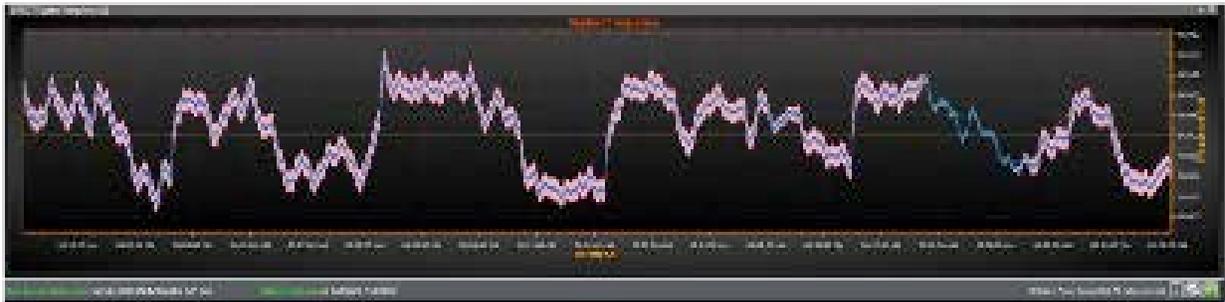
In February 2014, Electric Reliability Council of Texas (ERCOT) operations engineers noticed oscillations on their real-time dynamics monitoring system (RTDMS) displays of PMU data (see Figure 20). Examination revealed that the oscillations occurred only on Line 1 at the West 4 PMU location, as shown in Figure 21 and Figure 22.<sup>13</sup> ERCOT staff noticed that when the hydro unit closest to this PMU went offline, the oscillations died down, and when the second unit at the same plant was running no oscillations were observed. The same oscillatory pattern occurred again on February 27. Modal analysis of the oscillations indicated that the dominant mode was 1.8 Hz, indicating that the cause was a unit within the plant. After discussions between the ERCOT engineers and the power plant operator, they decided to change out some of the control cards for the problematic Unit 1, to test whether that would solve the problem. After the control cards were replaced, the plant was brought back online and the oscillations were significantly reduced.

**Figure 20. Frequency oscillations on RTDMS system**
