## EI Oscillation Event

January 11, 2019 Event

Tim Fritch, SMS Vice-Chair  
NASPI Meeting, April 17, 2019

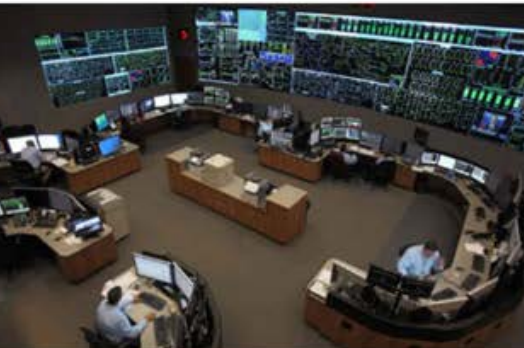
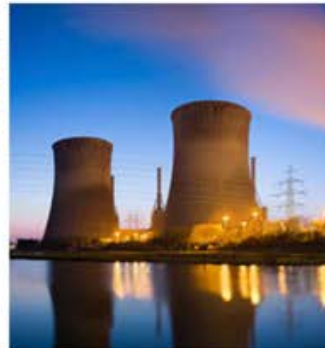
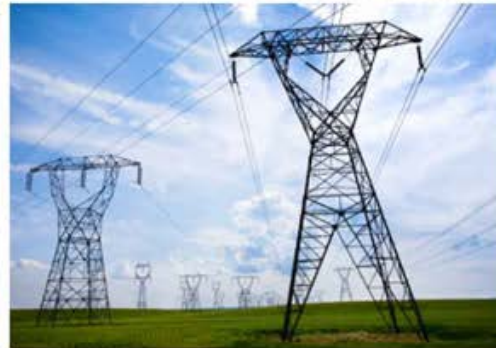
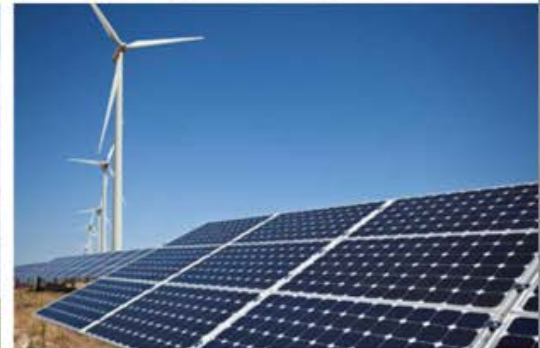
- Oscillation observed across entire Eastern Interconnection from 08:44:41 UTC (03:44:41 EDT) to 09:02:23 UTC (04:02:23 EDT)
  - Oscillation frequency of 0.25 Hz
    - Aligns with inter-area mode frequency across EI
  - Power swings around Florida of 200 MW, around ISO-NE of 50 MW
- RCs identified oscillation on PMU data, notified RC Hotline
- UTK provided videos of oscillation event
- GOs noticed oscillation on power plants across EI
- Source tentatively identified in Florida
- NERC issued PMU data request, working with possible source
- NERC will perform oscillation analysis on wide-area data set
- NERC working with industry to study event, develop mitigating actions

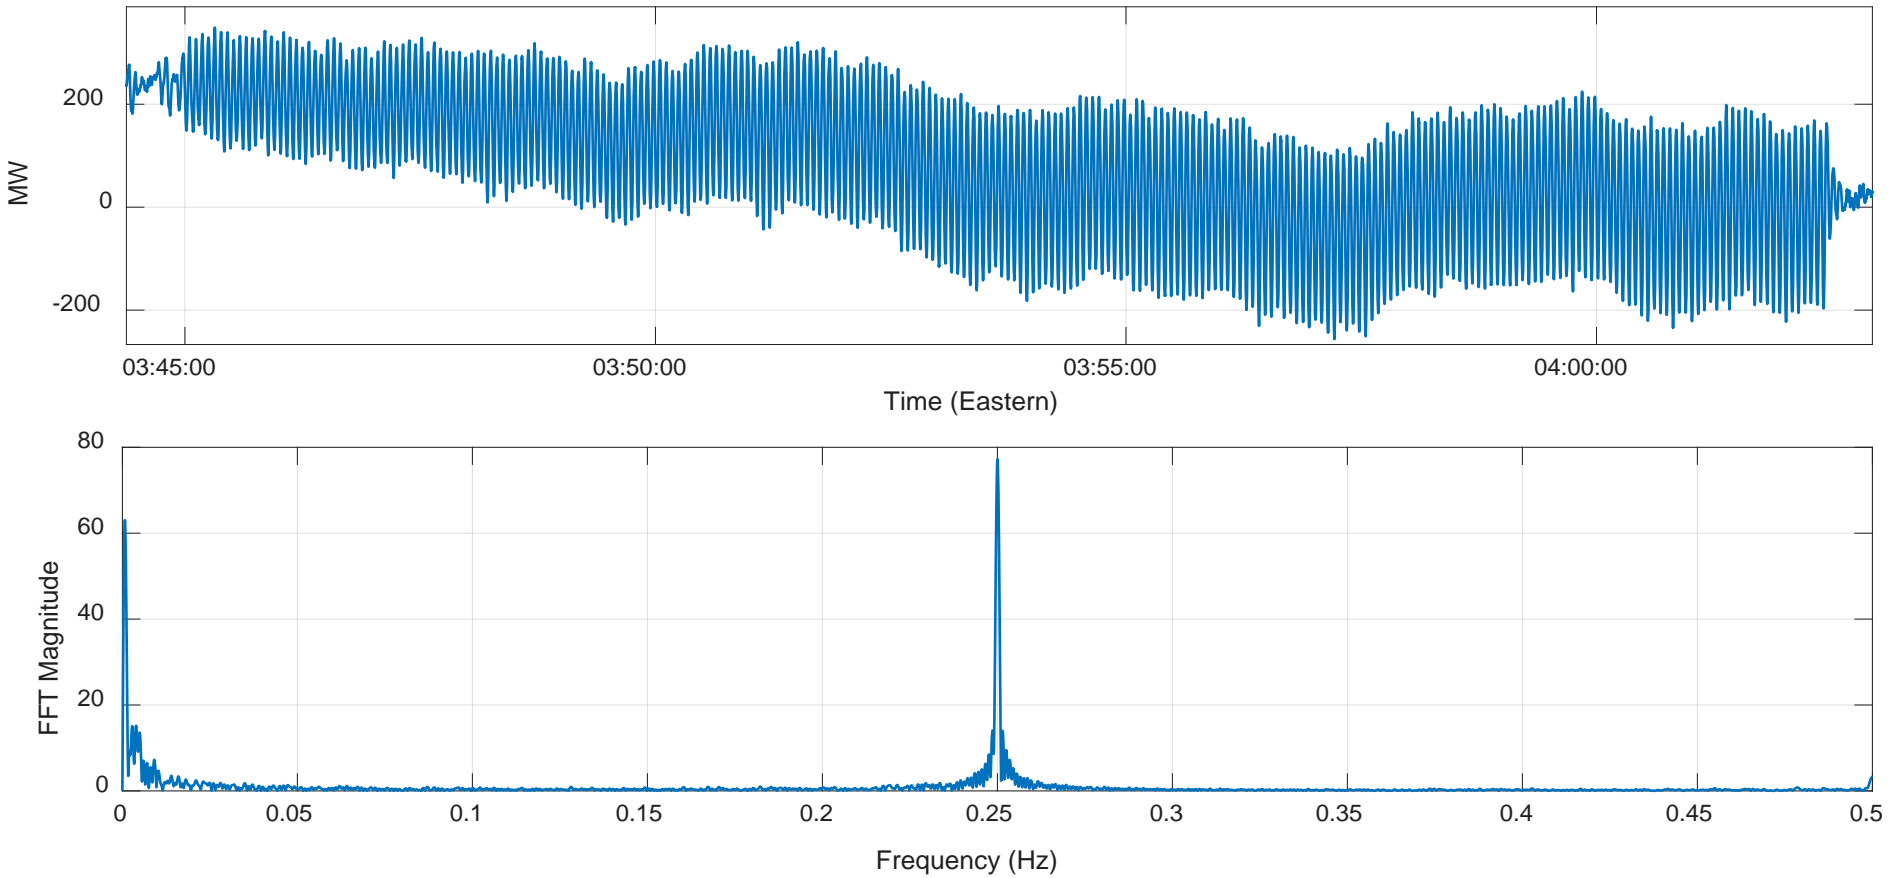
- ISO-NE Phasorpoint generated 14 alarms (20+ Alerts) from 3:46-4:03 AM, 0.249 Hz oscillation, magnitudes up to 10-15 MW RMS
- OSL application automatically processed Alarms and Alerts, identified source of oscillations located beyond ISO-NE area
- Plot: MW flow on 345KV line between NE and NY.
