Recent BESS Oscillations: Root Cause Analysis and Wide-Area Impacts

NASPI Webinar, 7/10/2024

Matt Rhodes and Daniel Goodrich

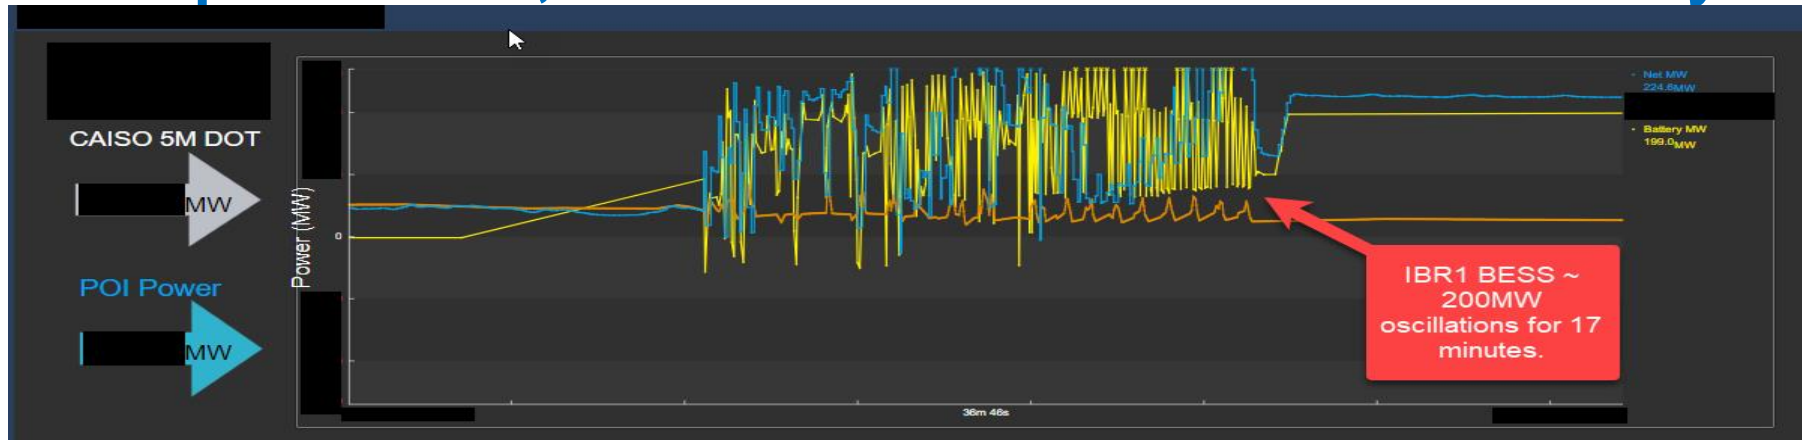
September 20, 2023 IBR1 BESS Oscillation Summary

- **Event details:** Event identified after RC West called SRPs control room via Pi Vision displays. IBR Operator was able to take the unit to local to arrest the oscillation.

- **Cause:** Error in the Metering Loss Compensation Methodology
- **Solution:** Near term - Logic reverted to use uncompensated meter data. Long term – Fix compensated meter data and put back in place at this and other IBR operated sites for SRP – fix began 12/11/23 estimated completion 1/15/24.

- **WECC Impact:** Frequency of forced oscillations (0.25 Hz) was close to that of NS-A mode frequency causing the Modemeter to trigger alerts for NS-A mode critical damping ratio. Actual damping ratio remained unaffected (The damping ratio of a mode is essentially biased in the presence of forced oscillations having frequency close to that of the mode). RC West mode meters detected forced oscillation. RC West and BPA ODM (Oscillation Detection Module) tool detected forced oscillations with low damping ratio alerts triggered in the RC West Modemeter for NS-A mode. Oscillations in current and frequency across major WI 500kV lines.

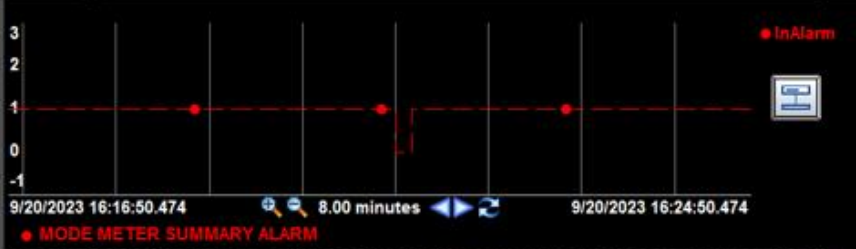
N-S MODE WARNING MONITOR

9/20/2023 16:35:00

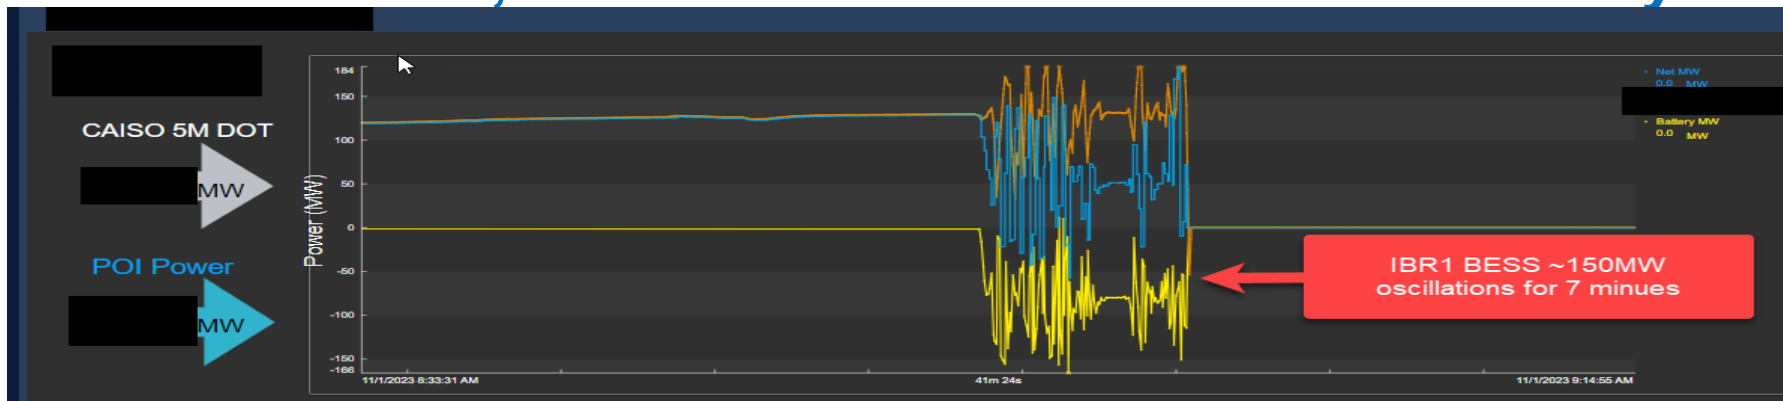
November 1, 2023 IBR1 BESS Oscillation Summary

- **Event Details:** SRP control room operators via the PI Vision displays, noticed the oscillation and called IBR Operator to address. Following 9/20 event, SRP implemented a POI breaker tripping procedure after 3 minutes of oscillations present. The event here looked to stabilize partway through the event. Once the oscillation re-engaged, SRP opened the POI breakers.

- **Cause:** Three GSUs delivered output with differing polarity (some discharging, and some charging) that resulted in erroneous GSU MVA limits. Severity of event aggravated by delayed inverter startup which was sourced from a control's integrator error the previous day to shut down all inverters for controller changes rather than placing inverters in idle. Some inverters were driven to startup upon receiving a non-zero dispatch command which led to unbalanced inverter startup.

- **WECC Impact:** Frequency of forced oscillations (0.25 Hz) was close to that of NS-A mode frequency causing the Modemeter to trigger alerts for NS-A mode critical damping ratio. Actual damping ratio remained unaffected. BPA operators thought the oscillations were caused by unstable NS-A mode and inserted series capacitors to improve mode damping ratio with essentially no effect. RC West and BPA ODM tool detected forced oscillations with low damping ratio alerts triggered in the Modemeter for NS-A mode.

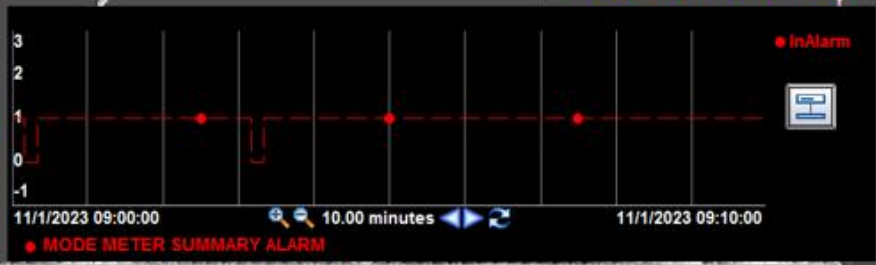
Fluctuations on 500 kV line

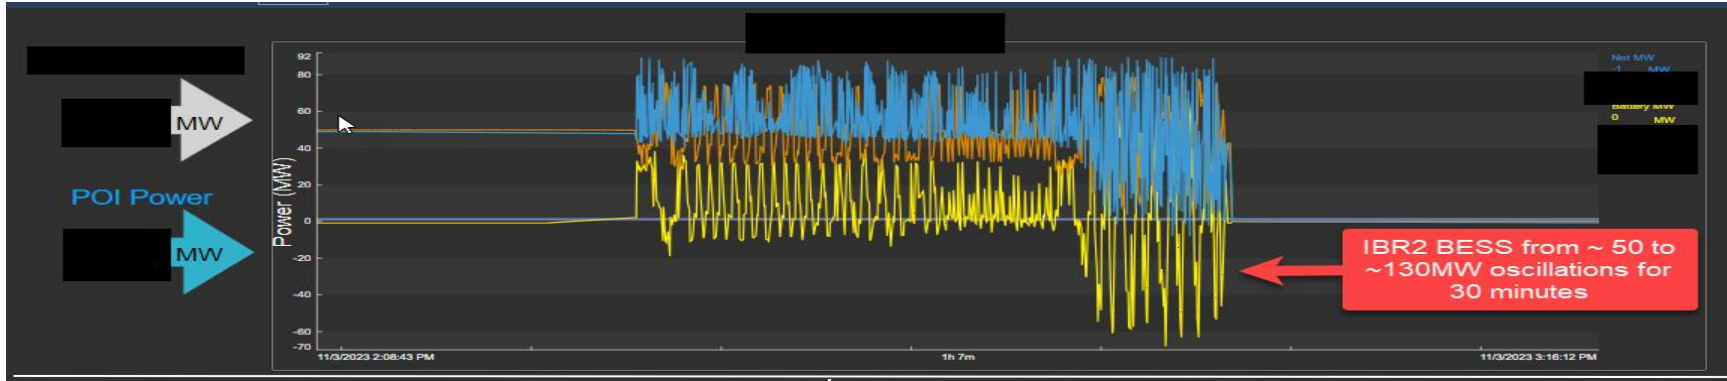
November 3, 2023 IBR2 BESS Oscillation Summary

- **Event details:** SRP control room operators noticed the oscillation via PI Vision displays and called IBR Operator to address. SRP opened the POI breakers after a delay in response from the IBR Operator.

- **Cause:** Dual meter switching logic (BESS meter for charging and BESS+PV meter for discharging) aggravated by erroneous PV output signal test hard coded to 0MW instead of actual PV output.

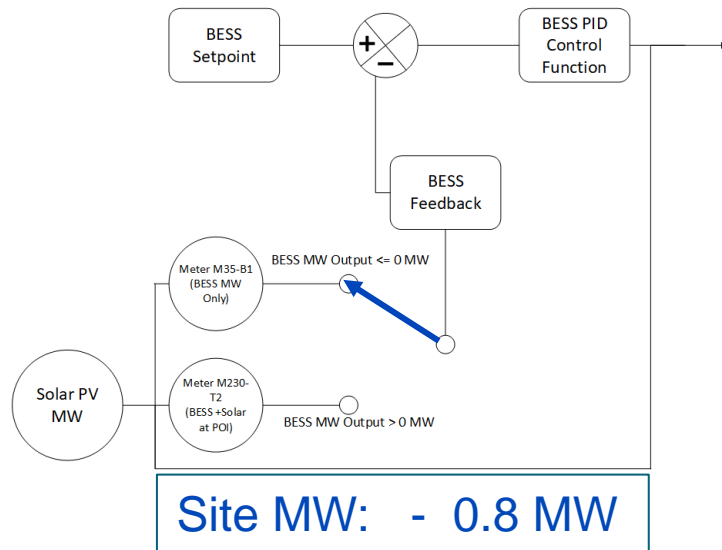
Sequence of Mis-operation

- Battery idle w/ ~ -0.8 M of auxiliary load
- Setpoint of 37 MW received
- BESS inverters wake and export power
- BESS output now positive, switch to alternate meter scheme
- PID sees battery MW too high, instruct rapid reduction of output
- Site MW goes negative, swaps meter scheme
- PID sees battery MW too low, instruct rapid increase in output
- Cycle repeats until shutdown

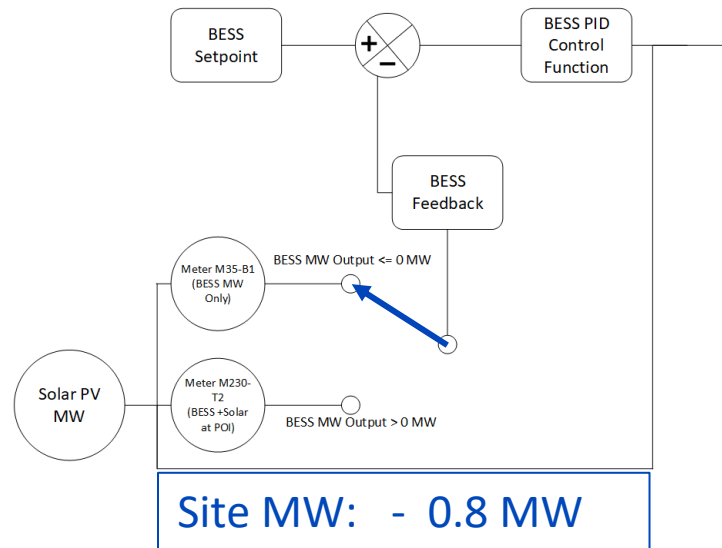
Sequence of Mis-operation

- Battery idle w/ ~ -0.8 M of auxiliary load
- Setpoint of 37 MW received
- BESS inverters wake and export power
- BESS output now positive, switch to alternate meter scheme
- PID sees battery MW too high, instruct rapid reduction of output
- Site MW goes negative, swaps meter scheme
- PID sees battery MW too low, instruct rapid increase in output
- Cycle repeats until shutdown

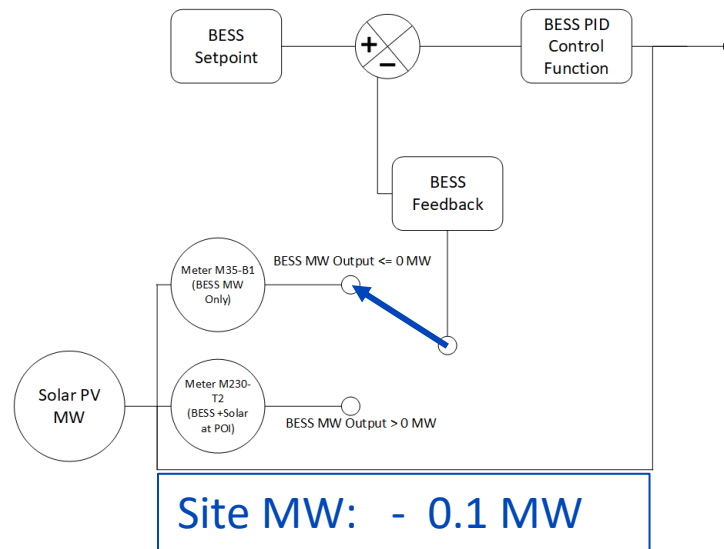
Sequence of Mis-operation

- Battery idle w/ ~ -0.8 M of auxiliary load
- Setpoint of 37 MW received
- BESS inverters wake and export power
- BESS output now positive, switch to alternate meter scheme
- PID sees battery MW too high, instruct rapid reduction of output
- Site MW goes negative, swaps meter scheme
- PID sees battery MW too low, instruct rapid increase in output
- Cycle repeats until shutdown
