NASPI Webinar

Preparing for the December 31, 2016 Leap Second

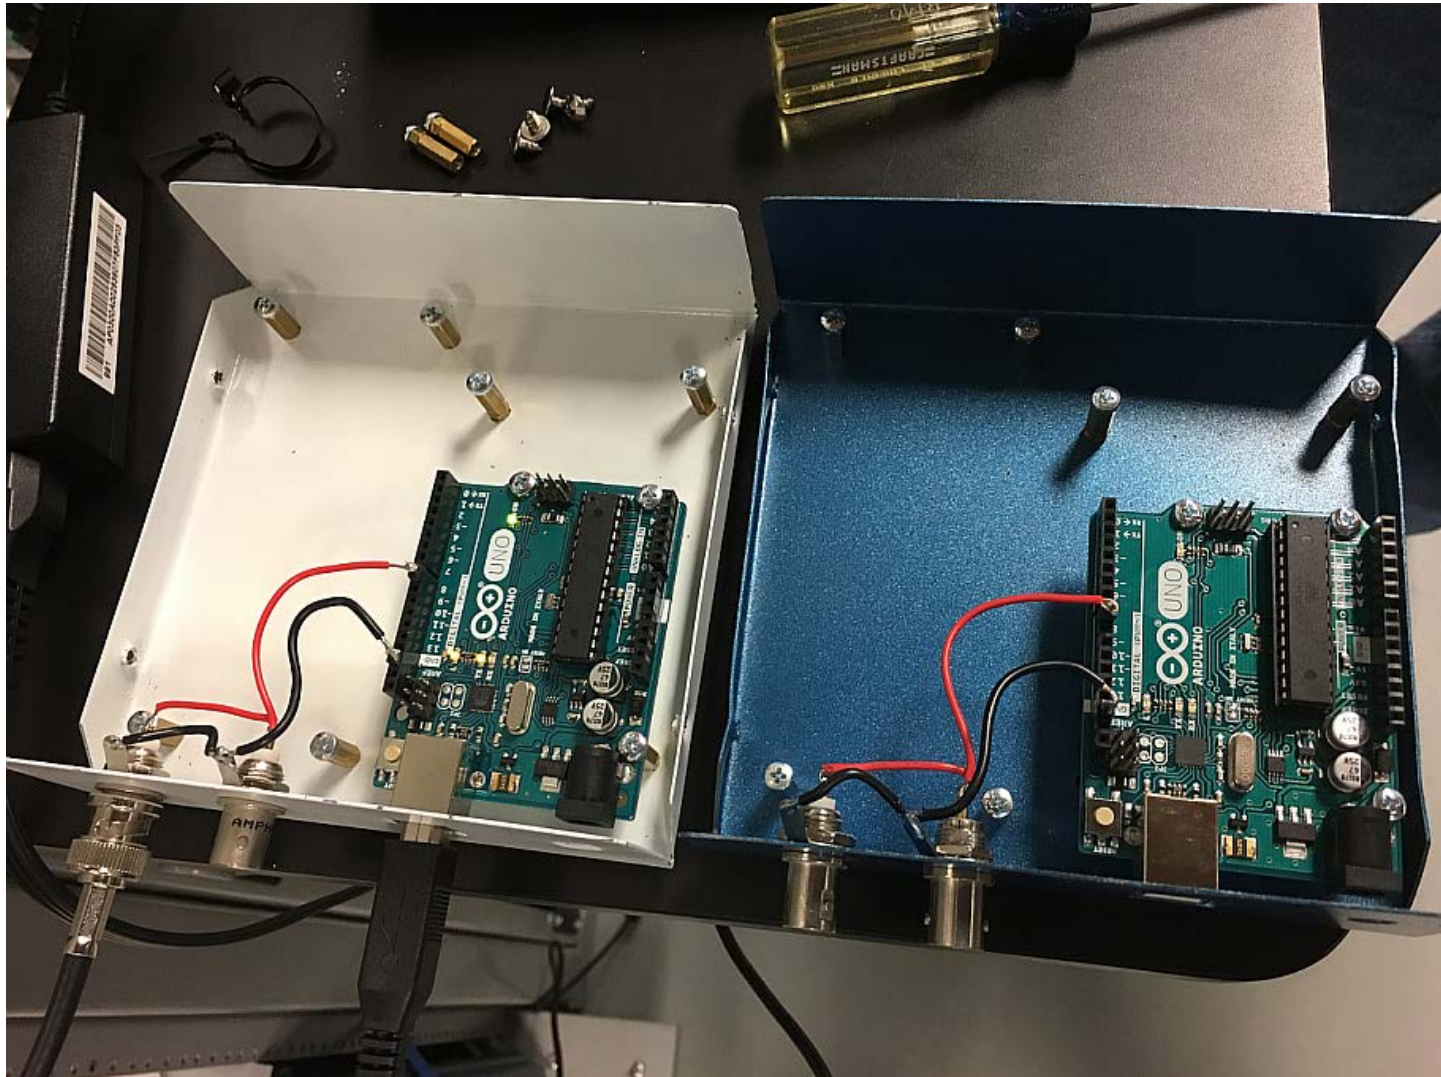
\$50 IRIG-B monitor

- Monitoring and logging of the IRIG-B timing output is very insightful
 - Without monitoring IRIG-B output of clock, when time errors occur do not know if the problem is the clock or the end-device (PMU, DFR, etc.)
 - Most issues we have found are in the GPS clock firmware
- By decoding the IRIG data stream we learned a lot. This data was previously unavailable to us due to a lack of tools
- New IRIG monitoring tools are now on the market

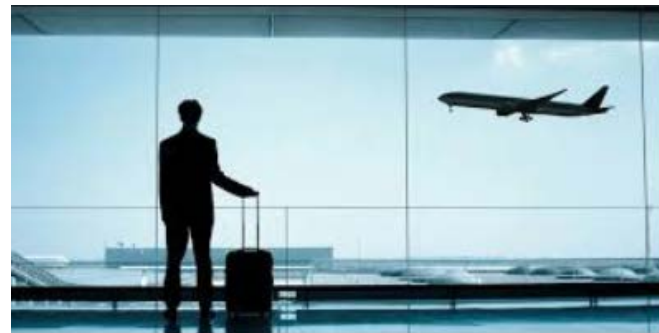
Leap Seconds in 2012 & 2015

- Hardware is the frontline and source
 - Clock & PMU
- Different clock & PMU pairs reacted differently
 - Adds complexity to the problem
- PDC late leap
 - Increased latency →
exceed wait time setting →
data loss
- No leap second timestamps / data points
 - E.g., 23:59:60.xxx UTC don't exist in the historian
 - Needs investigation

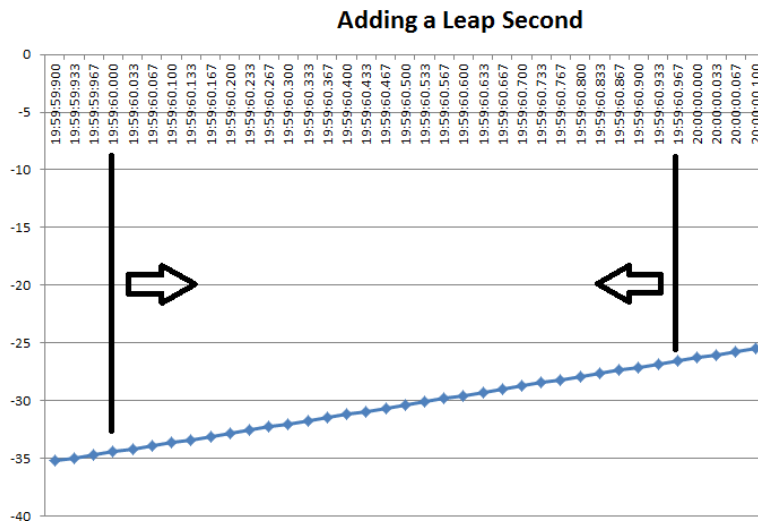
- Missing leap second data → Phasor Angle jump
- Hence the frequency and ROCOF jumps

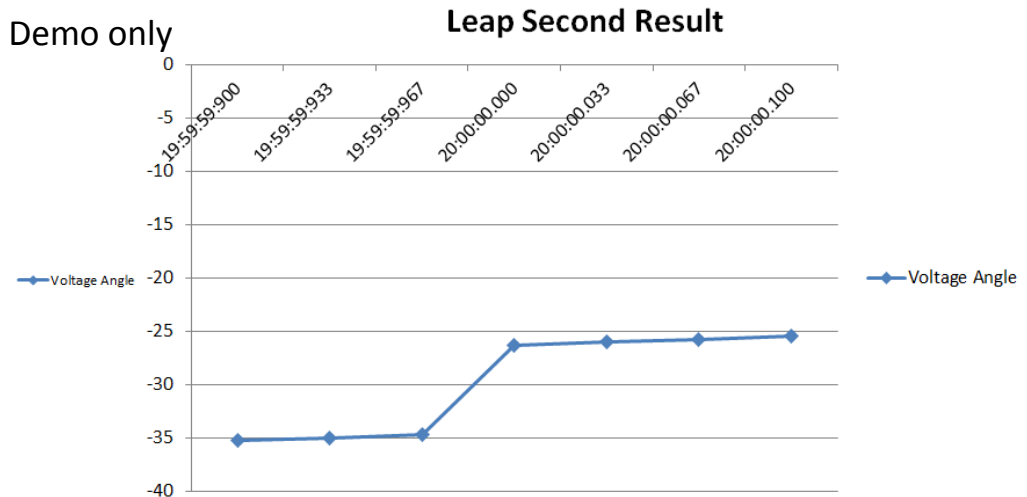
Demo only

$$\delta^{After} = \delta^{Before} + \delta^{Leap} = \delta^{Before} + (f - 60) \times \text{Leap} \times 360$$

f is system frequency at the time, usually not nominal (60 Hz)
