Austin D. White P.E.

Oklahoma Gas & Electric

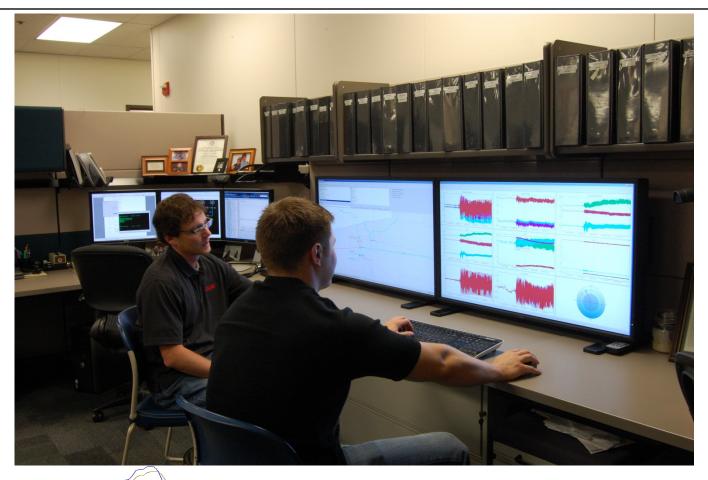
Client Visualization Station

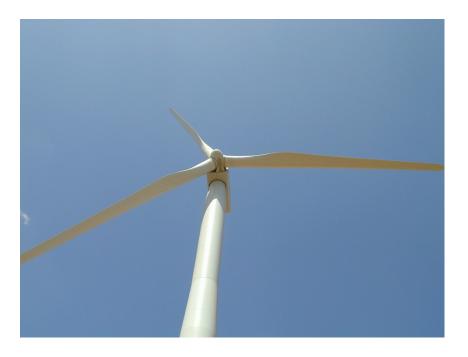
Integration of Renewable Energy

- With over 28GW of wind power in the SPP interconnection queue, this is a big deal!
- OG&E requires a PMU at the point of interconnection for every wind farm
- We feel this is very important to monitor power quality and dynamic response
